General Information

Make	Suzuki	Model	Dzire
YOM	2025	Odo Meter Reading	7,727
Registration No.	GBJ8894	Chassis No.	MBHZF63S5SG591422
CC	1.2	Transmission	A/T
Fuel Type	Gas	Type of Body	Sedan
Colour	Red

Body / Panel Condition

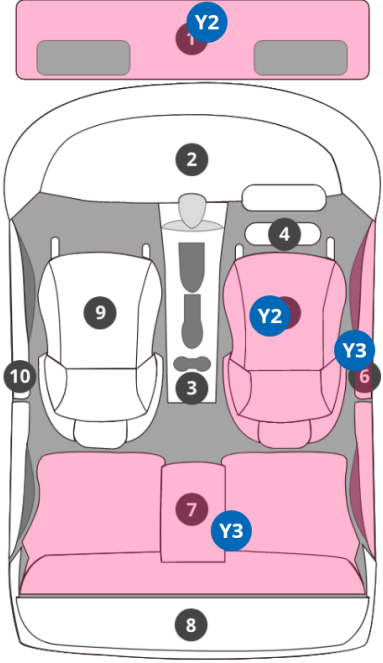
<p>A : Scratch AU : Scratch & Dent B : Modified C : Corrosion G : Stone chip P : Faded S : Rust SC : Rust & Corrosion U : Dent X : Defective Y : Crack, Gap</p>
<p>Remarks (R) Front Seat - Grime - Small / Rear Seat - Grime - Medium / (R) Front Trim - Grime - Medium / Ceiling - Grime - Small</p>	<p>Remarks (L) Rear Door, Molding - Scratch & Dent - Medium / (R) Front Door, Molding - Dent - Small / Rear Bumper, Lamps, Panels - Scratch - Medium / Bonnet, Headlight - Scratch - Small / (L) Front Fender, Molding - Scratch - Minimal / (L) Front Door, Molding - Scratch - Medium</p>
Frame Evaluation : A	Functional Evaluation : B
<p>Remarks Defects not found</p>	<p>Remarks Battery - Weak - Yes</p>
