General Information

Make	Toyota	Model	Vios
YOM	2024	Odo Meter Reading	12,265
Registration No.	CCD1317	Chassis No.	PA1B18F30R4240259
CC	1.3	Transmission	CVT
Fuel Type	Gas	Type of Body	Sedan
Colour	Red Mica Metallic

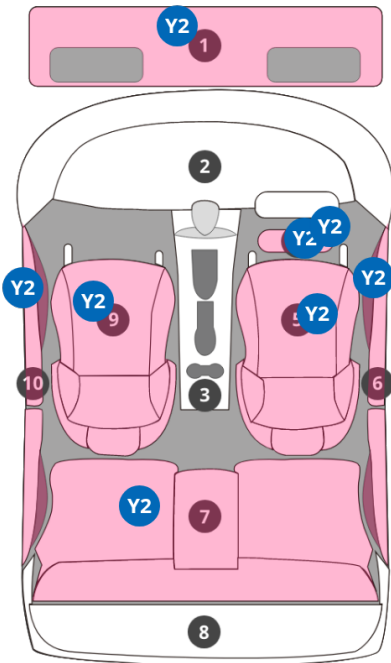
Interior Evaluation : B	Exterior Evaluation : D

<p>a : Cut, Fray d : Loose, Deformed k : Animal Hair s : Smell t : Cigarette Burns x : Defective y : Stain</p>

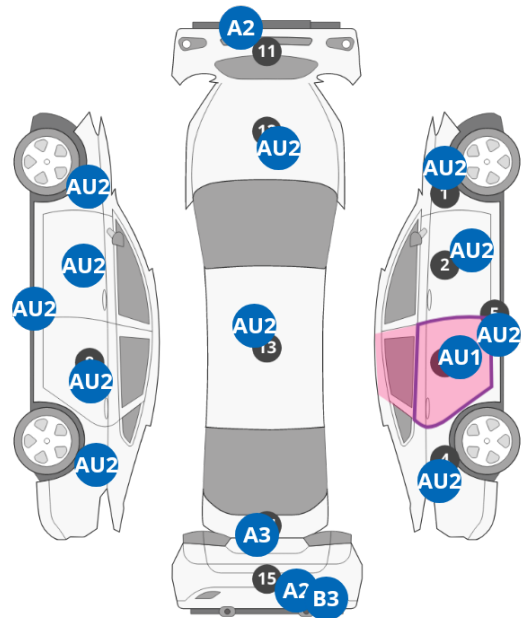
<p>A : Scratch AU : Scratch & Dent B : Modified C : Corrosion G : Stone chip P : Faded S : Rust SC : Rust & Corrosion U : Dent X : Defective Y : Crack, Gap</p>
<p>Remarks (L) Front Floor Mat - Grime - Small / (R) Front Floor Mat - Grime - Small / (L) Front Trim - Grime - Small / (R) Front Trim - Grime - Small / (L) Front Seat - Grime - Small / (R) Front Seat - Grime - Small / Rear Seat - Grime - Small / Ceiling - Grime - Small</p>	<p>Remarks (R) Rear Door - Repair Traces - Yes / Roof - Scratch & Dent - Small / (L) Front Fender, Molding - Scratch & Dent - Small / Bonnet, Headlight - Scratch & Dent - Small / (R) Front Fender, Molding - Scratch & Dent - Small / Front Bumper, Grille, Lamps - Scratch - Small / (R) Front Door, Molding - Scratch & Dent - Small / (R) Rear Door, Molding - Scratch & Dent - Minimal / (R) Rear Door, Molding - Repair mark - Yes / (R) Rear Fender, Molding - Scratch & Dent - Small / Trunk Hood, Rear Gate - Scratch - Medium / Rear Bumper, Lamps, Panels - Scratch - Small / Rear Bumper, Lamps, Panels - Modified - Medium / (L) Rear Fender, Molding - Scratch & Dent - Small / (L) Front Door, Molding - Scratch & Dent - Small / (L) Step, In-panel, Side Spoiler - Scratch & Dent - Small / (R) Step, In-panel, Side Spoiler - Scratch & Dent - Small / (L) Rear Door, Molding - Scratch & Dent - Small</p>
