General Information

Make	Toyota	Model	Wigo
YOM	2024	Odo Meter Reading	22,615
Registration No.	DBF9433	Chassis No.	MHKAA1BC1RJ015697
CC	1.0	Transmission	CVT
Fuel Type	Gas	Type of Body	Hatchback
Colour	Yellow

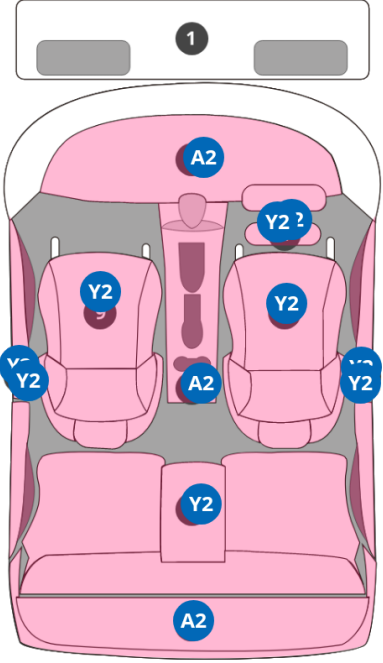
Interior Evaluation : C	Exterior Evaluation : C

<p>a : Cut, Fray d : Loose, Deformed k : Animal Hair s : Smell t : Cigarette Burns x : Defective y : Stain</p>

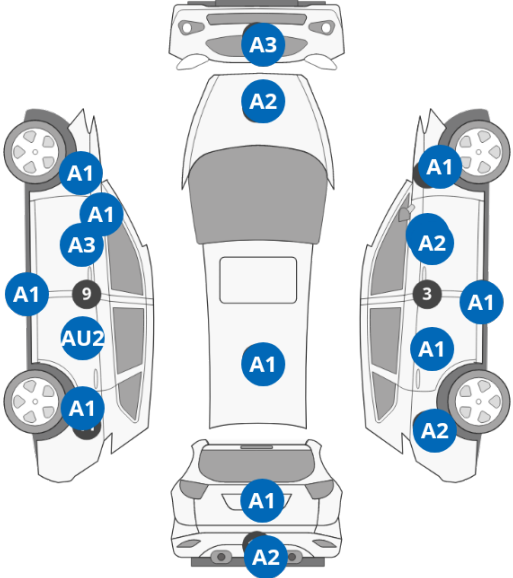
<p>A : Scratch AU : Scratch & Dent B : Modified C : Corrosion G : Stone chip P : Faded S : Rust SC : Rust & Corrosion U : Dent X : Defective Y : Crack, Gap</p>
Remarks (R) Front Seat - Grime - Small / Trunk Room - Worn, Scratch, Cut, Crack - Small / (L) Front Seat - Grime - Small / Dashboard - Worn, Scratch, Cut, Crack - Small / Rear Seat - Grime - Small / (R) Front Floor Mat - Grime - Small / (L) Front Floor Mat - Grime - Small / Console, Switches, Vents - Worn, Scratch, Cut, Crack - Small / (R) Front Trim - Grime - Small / (R) Rear Trim - Grime - Small / (L) Front Trim - Grime - Small / (L) Rear Trim - Grime - Small	Remarks Bonnet, Headlight - Scratch - Small / Front Bumper, Grille, Lamps - Scratch - Medium / (L) Front Door, Molding - Scratch - Medium / (L) Rear Door, Molding - Scratch & Dent - Small / (L) Mirror - Scratch - Minimal / (L) Rear Fender, Molding - Scratch - Minimal / Roof - Scratch - Minimal / Trunk Hood, Rear Gate - Scratch - Minimal / Rear Bumper, Lamps, Panels - Scratch - Small / (R) Rear Fender, Molding - Scratch - Small / (R) Rear Door, Molding - Scratch - Minimal / (R) Front Door, Molding - Scratch - Small / (R) Mirror - Scratch - Small / (R) Front Fender, Molding - Scratch - Minimal / (L) Front Fender, Molding - Scratch - Minimal / (L) Step, In-panel, Side Spoiler - Scratch - Minimal / (R) Step, In-panel, Side Spoiler - Scratch - Minimal
