General Information

Make	Toyota	Model	Vios
YOM	2024	Odo Meter Reading	12,117
Registration No.	DBO9684	Chassis No.	PA1B18F36R4259012
CC	1.3	Transmission	CVT
Fuel Type	Gas	Type of Body	Sedan
Colour	Red Mica Metallic

Body / Panel Condition

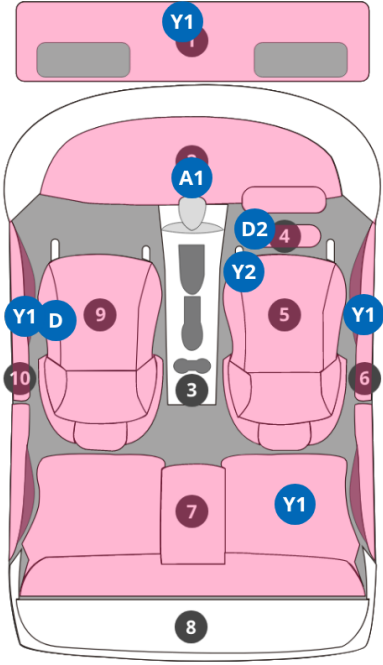
Interior Evaluation : B	Exterior Evaluation : E

<p>a : Cut, Fray d : Loose, Deformed k : Animal Hair s : Smell t : Cigarette Burns x : Defective y : Stain</p>

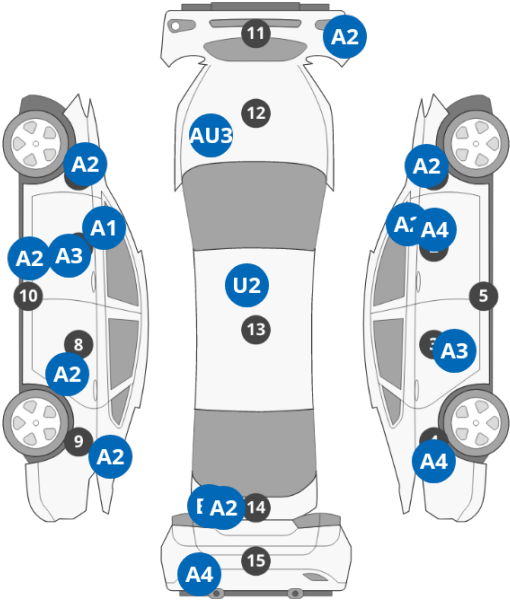
<p>A : Scratch AU : Scratch & Dent B : Modified C : Corrosion G : Stone chip P : Faded S : Rust SC : Rust & Corrosion U : Dent X : Defective Y : Crack, Gap</p>
<p>Remarks (L) Front Seat - Worn - Yes / (R) Front Seat - Grime - Small / (R) Front Trim - Grime - Minimal / (L) Front Trim - Grime - Minimal / (L) Front Floor Mat - Worked - Small / Ceiling - Grime - Minimal / Rear Seat - Grime - Minimal / Dashboard - Worn, Scratch, Cut, Crack - Minimal</p>	<p>Remarks (R) Front Fender, Molding - Scratch - Small / (R) Mirror - Scratch - Small / (R) Front Door, Molding - Scratch - Large / (R) Rear Door, Molding - Scratch - Medium / (R) Rear Fender, Molding - Scratch - Large / Rear Bumper, Lamps, Panels - Scratch - Large / Trunk Hood, Rear Gate - Modified - Medium / Trunk Hood, Rear Gate - Scratch - Small / (L) Rear Fender, Molding - Scratch - Small / (L) Rear Door, Molding - Scratch - Small / (L) Front Door, Molding - Scratch - Medium / (L) Step, In-panel, Side Spoiler - Scratch - Small / (L) Front Fender, Molding - Scratch - Small / (L) Mirror - Scratch - Minimal / Bonnet, Headlight - Scratch & Dent - Medium / Front Bumper, Grille, Lamps - Scratch - Small / Roof - Dent - Small</p>

<p>Inspector Notes</p>
<p>with warranty booklet, no jack and tools, with spare tire, with LTO plate, scratched and cracked tail light</p>
