General Information

Make	Toyota	Model	Avanza
YOM	2025	Odo Meter Reading	5,618
Registration No.	DBQ6543	Chassis No.	MHFAA1BY2R0030418
CC	1.3	Transmission	CVT
Fuel Type	Gas	Type of Body	MPV
Colour	Red Mica Metallic

Body / Panel Condition

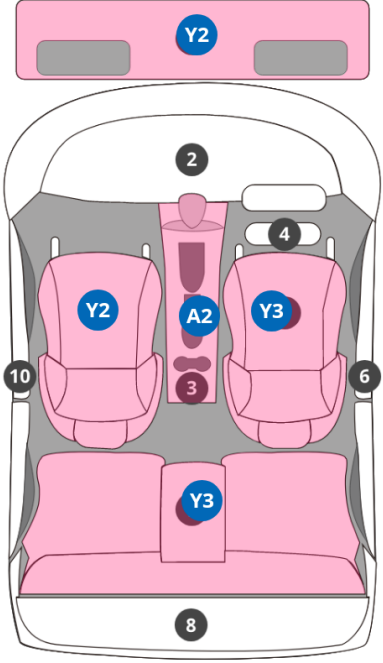
Interior Evaluation : B	Exterior Evaluation : C

<p>a : Cut, Fray d : Loose, Deformed k : Animal Hair s : Smell t : Cigarette Burns x : Defective y : Stain</p>

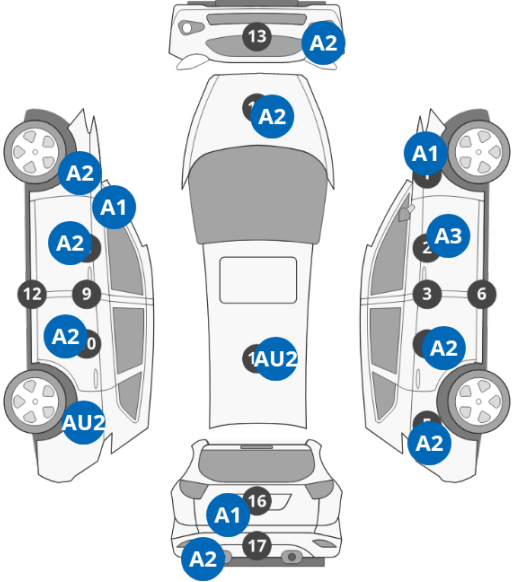
<p>A : Scratch AU : Scratch & Dent B : Modified C : Corrosion G : Stone chip P : Faded S : Rust SC : Rust & Corrosion U : Dent X : Defective Y : Crack, Gap</p>
<p>Remarks (R) Front Seat - Grime - Medium / Rear Seat - Grime - Medium / (L) Front Seat - Grime - Small / Console, Switchs, Vents - Worn, Scratch, Cut, Crack - Small / Ceiling - Grime - Small</p>	<p>Remarks Bonnet, Headlight - Scratch - Small / Front Bumper, Grille, Lamps - Scratch - Small / (R) Front Door, Molding - Scratch - Medium / (R) Rear Fender, Molding - Scratch - Small / (R) Front Fender, Molding - Scratch - Minimal / Trunk Hood, Rear Gate - Scratch - Minimal / (L) Rear Fender, Molding - Scratch & Dent - Small / (L) Front Fender, Molding - Scratch - Small / (L) Mirror - Scratch - Minimal / (L) Front Door, Molding - Scratch - Small / (L) Rear Door, Molding - Scratch - Small / Rear Bumper, Lamps, Panels - Scratch - Small / (R) Rear Door, Molding - Scratch - Small / Roof - Scratch & Dent - Small</p>
