General Information

Make	Toyota	Model	Avanza
YOM	2025	Odo Meter Reading	41,206
Registration No.	DBR4397	Chassis No.	MHFAA1BY1R0030649
CC	1.3	Transmission	CVT
Fuel Type	Gas	Type of Body	MPV
Colour	Black

Body / Panel Condition

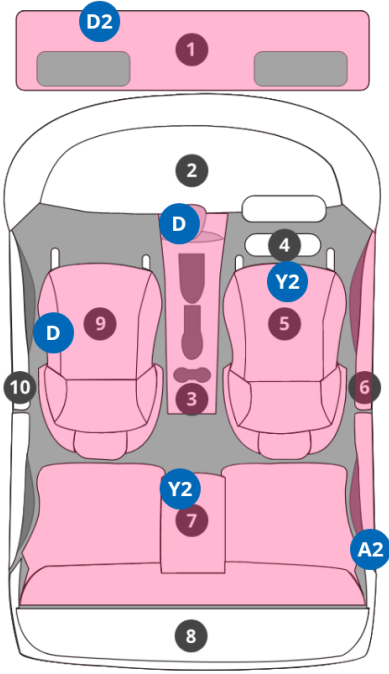
Interior Evaluation : B	Exterior Evaluation : E

<p>a : Cut, Fray d : Loose, Deformed k : Animal Hair s : Smell t : Cigarette Burns x : Defective y : Stain</p>

<p>A : Scratch AU : Scratch & Dent B : Modified C : Corrosion G : Stone chip P : Faded S : Rust SC : Rust & Corrosion U : Dent X : Defective Y : Crack, Gap</p>
Remarks (L) Front Seat - Worn - Yes / (R) Front Seat - Grime - Small / Rear Seat - Grime - Small / Console, Switches, Vents - Traces of Adhesive Tape - Yes / Trim Other - Cut, Crack - Small / Ceiling - Crinkle - Small	Remarks (R) Front Fender, Molding - Scratch - Small / (R) Mirror - Scratch - Minimal / (R) Step, In-panel, Side Spoiler - Scratch & Dent - Small / (R) Front Door, Molding - Scratch - Small / (R) Rear Door, Molding - Scratch - Large / Rear Bumper, Lamps, Panels - Scratch & Dent - Small / Trunk Hood, Rear Gate - Scratch - Minimal / (L) Rear Fender, Molding - Scratch - Small / (L) Rear Door, Molding - Scratch & Dent - Small / (L) Front Door, Molding - Scratch - Medium / (L) Mirror - Scratch - Small / (L) Front Fender, Molding - Scratch - Small / Bonnet, Headlight - Scratch - Small / Roof - Scratch & Dent - Small / (R) Rear Fender, Molding - Scratch & Dent - Small / Front Bumper, Grille, Lamps - Scratch & Dent - Medium

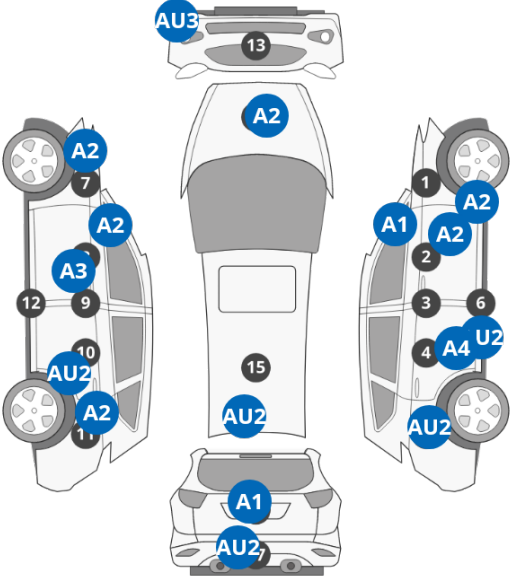
Inspector Notes
no warranty booklet, with jack, incomplete tools, with spare tire, with LTO plate, scratches on tail light, air-conditioning system issue
