General Information

Make	Toyota	Model	Hiace
YOM	2023	Odo Meter Reading	62,257
Registration No.	NFA4623	Chassis No.	JTFJT02P9P0016349
CC	3.0	Transmission	M/T
Fuel Type	Diesel	Type of Body	Van
Colour	Silver

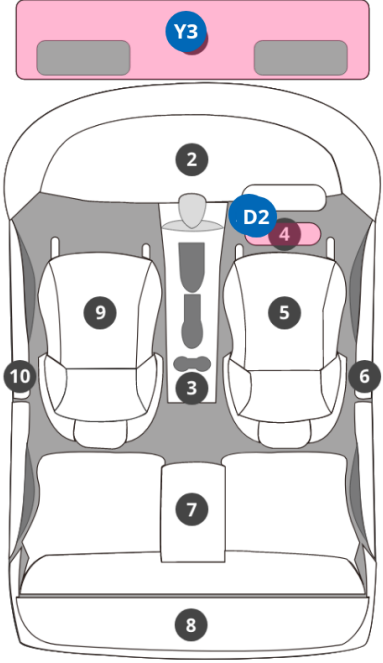
Interior Evaluation : B	Exterior Evaluation : E

<p>a : Cut, Fray d : Loose, Deformed k : Animal Hair s : Smell t : Cigarette Burns x : Defective y : Stain</p>

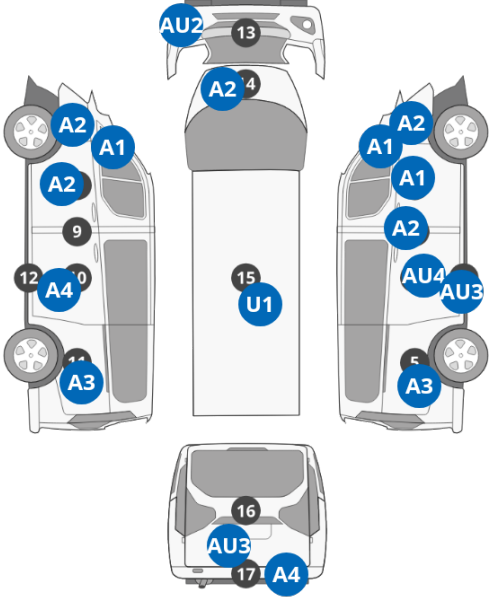
<p>A : Scratch AU : Scratch & Dent B : Modified C : Corrosion G : Stone chip P : Faded S : Rust SC : Rust & Corrosion U : Dent X : Defective Y : Crack, Gap</p>
<p>Remarks (L) Front Floor Mat - Cut, Crack - Small / Ceiling - Grime - Medium / (L) Front Floor Mat - Worked - Small</p>	<p>Remarks (R) Front Fender, Molding - Scratch - Small / (R) Mirror - Scratch - Minimal / (R) Front Door, Molding - Scratch - Minimal / (R) Center Panel - Scratch - Small / (R) Rear Door, Molding - Scratch & Dent - Large / (R) Step, In-panel, Side Spoiler - Scratch & Dent - Medium / (R) Rear Fender, Molding - Scratch - Medium / Rear Bumper, Lamps, Panels - Scratch - Large / Trunk Hood, Rear Gate - Scratch & Dent - Medium / (L) Rear Fender, Molding - Scratch - Medium / (L) Rear Door, Molding - Scratch - Large / (L) Front Door, Molding - Scratch - Small / (L) Mirror - Scratch - Minimal / (L) Front Fender, Molding - Scratch - Small / Front Panel - Scratch - Small / Front Bumper, Grille, Lamps - Scratch & Dent - Small / Roof - Dent - Minimal</p>

<p>Inspector Notes</p>
<p>with warranty booklet, no jack and tools, with spare tire, with LTO plate, scratched and cracked tail light,</p>
