General Information

Make	Toyota	Model	Vios
YOM	2025	Odo Meter Reading	22,784
Registration No.	NGC9585	Chassis No.	PA1B18F3XR427594
CC	1.3	Transmission	CVT
Fuel Type	Gas	Type of Body	Sedan
Colour	Black

Body / Panel Condition

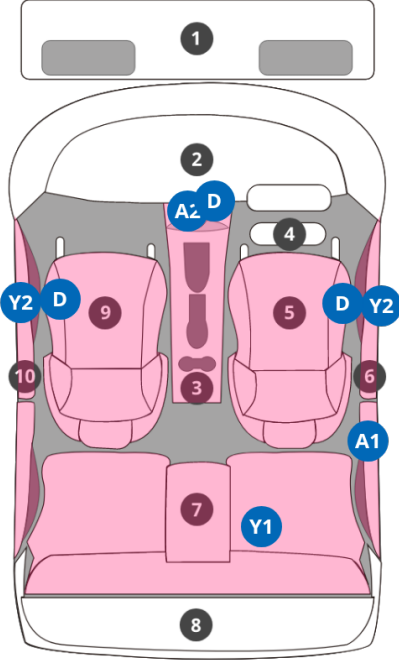
Interior Evaluation : B	Exterior Evaluation : E

<p>a : Cut, Fray d : Loose, Deformed k : Animal Hair s : Smell t : Cigarette Burns x : Defective y : Stain</p>

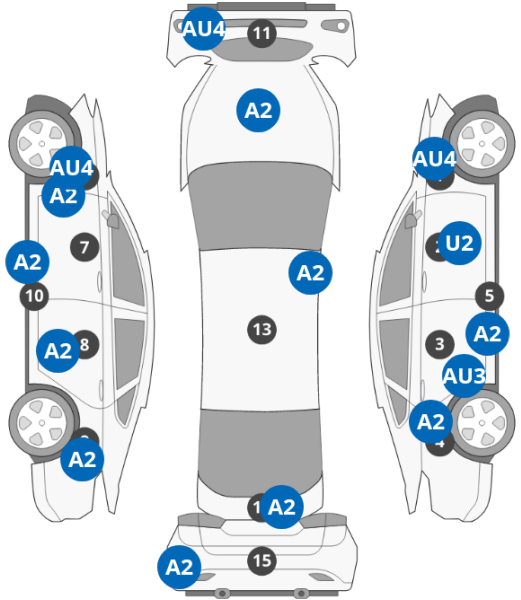
<p>A : Scratch AU : Scratch & Dent B : Modified C : Corrosion G : Stone chip P : Faded S : Rust SC : Rust & Corrosion U : Dent X : Defective Y : Crack, Gap</p>
<p>Remarks (R) Front Trim - Grime - Small / (L) Front Trim - Grime - Small / Rear Seat - Grime - Minimal / (R) Front Seat - Worn - Yes / (L) Front Seat - Worn - Yes / Console, Switchs, Vents - Worn, Scratch, Cut, Crack - Small / Console, Switchs, Vents - Traces of Adhesive Tape - Yes / (R) Rear Trim - Cut, Crack - Minimal</p>	<p>Remarks (R) Front Fender, Molding - Scratch & Dent - Large / (R) Front Door, Molding - Dent - Small / (R) Rear Door, Molding - Scratch & Dent - Medium / (R) Step, In-panel, Side Spoiler - Scratch - Small / (R) Rear Fender, Molding - Scratch - Small / Rear Bumper, Lamps, Panels - Scratch - Small / Trunk Hood, Rear Gate - Scratch - Small / (L) Rear Fender, Molding - Scratch - Small / (L) Rear Door, Molding - Scratch - Small / (L) Step, In-panel, Side Spoiler - Scratch - Small / (L) Front Door, Molding - Scratch - Small / (L) Front Fender, Molding - Scratch & Dent - Large / Front Bumper, Grille, Lamps - Scratch & Dent - Large / Bonnet, Headlight - Scratch - Small / Roof - Scratch - Small</p>
