General Information

Make	Toyota	Model	Vios
YOM	2025	Odo Meter Reading	56,714
Registration No.	NGC9664	Chassis No.	PA1B18F36R4274075
CC	1.3	Transmission	CVT
Fuel Type	Gas	Type of Body	Sedan
Colour	Black

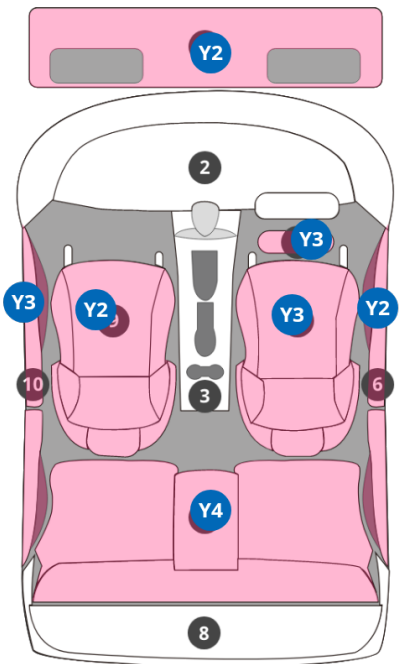
<p>a : Cut, Fray d : Loose, Deformed k : Animal Hair s : Smell t : Cigarette Burns x : Defective y : Stain</p>

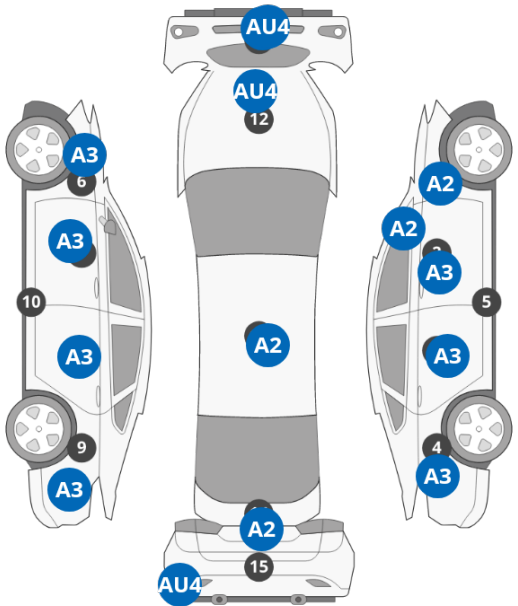
<p>A : Scratch AU : Scratch & Dent B : Modified C : Corrosion G : Stone chip P : Faded S : Rust SC : Rust & Corrosion U : Dent X : Defective Y : Crack, Gap</p>
<p>Remarks (R) Front Seat - Grime - Medium / (R) Front Trim - Grime - Small / Rear Seat - Grime - Large / (L) Front Trim - Grime - Medium / (L) Front Floor Mat - Grime - Medium / (L) Front Seat - Grime - Small / Ceiling - Grime - Small</p>	<p>Remarks Trunk Hood, Rear Gate - Scratch - Small / Rear Bumper, Lamps, Panels - Scratch & Dent - Large / (L) Rear Door, Molding - Scratch - Medium / (L) Front Door, Molding - Scratch - Medium / (L) Front Fender, Molding - Scratch - Medium / Bonnet, Headlight - Scratch & Dent - Large / Member (Bolted) - Dent - Yes / Front Bumper, Grille, Lamps - Scratch & Dent - Large / (R) Front Fender, Molding - Scratch - Small / (R) Mirror - Scratch - Small / (R) Front Door, Molding - Scratch - Medium / (R) Rear Door, Molding - Scratch - Medium / (R) Rear Fender, Molding - Scratch - Medium / Roof - Scratch - Small / (L) Rear Fender, Molding - Scratch - Medium</p>
