General Information

Make	Toyota	Model	Vios
YOM	2023	Odo Meter Reading	80,771
Registration No.	NHI2162	Chassis No.	PA1B18F38P4203103
CC	1.3	Transmission	CVT
Fuel Type	Gas	Type of Body	Sedan
Colour	Red Mica Metallic

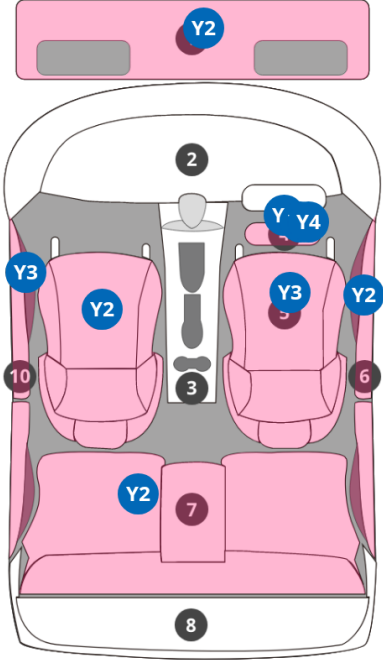
Interior Evaluation : C	Exterior Evaluation : D

<p>a : Cut, Fray d : Loose, Deformed k : Animal Hair s : Smell t : Cigarette Burns x : Defective y : Stain</p>

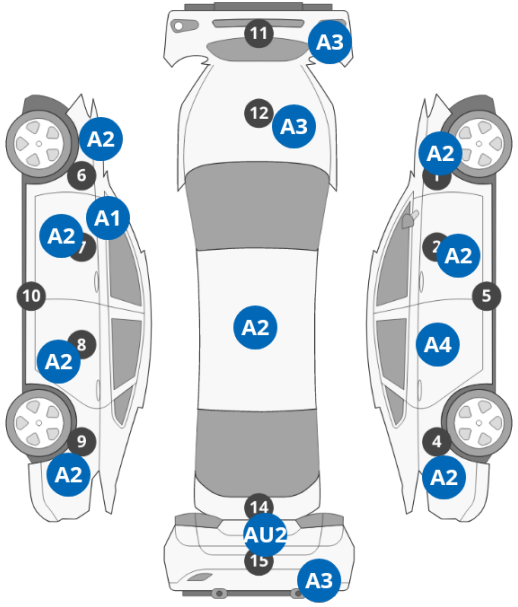
<p>A : Scratch AU : Scratch & Dent B : Modified C : Corrosion G : Stone chip P : Faded S : Rust SC : Rust & Corrosion U : Dent X : Defective Y : Crack, Gap</p>
<p>Remarks (R) Front Floor Mat - Grime - Medium / (R) Front Seat - Grime - Medium / (R) Front Trim - Grime - Small / Rear Seat - Grime - Small / Mat Other - Grime - Medium / (L) Front Trim - Grime - Medium / (L) Front Seat - Grime - Small / (L) Front Floor Mat - Grime - Large / Ceiling - Grime - Small</p>	<p>Remarks Roof - Scratch - Small / (L) Rear Fender, Molding - Scratch - Small / (L) Rear Door, Molding - Scratch - Small / (L) Mirror - Scratch - Minimal / (L) Front Door, Molding - Scratch - Small / (L) Front Fender, Molding - Scratch - Small / Bonnet, Headlight - Scratch - Medium / Front Bumper, Grille, Lamps - Scratch - Medium / (R) Front Fender, Molding - Scratch - Small / (R) Front Door, Molding - Scratch - Small / (R) Rear Door, Molding - Scratch - Large / (R) Rear Fender, Molding - Scratch - Small / Trunk Hood, Rear Gate - Scratch & Dent - Small / Rear Bumper, Lamps, Panels - Scratch - Medium</p>
