General Information

Make	Toyota	Model	Innova
YOM	2024	Odo Meter Reading	106,507
Registration No.	NHM7275	Chassis No.	PA2JA8EM4R0136561
CC	2.8	Transmission	A/T
Fuel Type	Diesel	Type of Body	Wagon
Colour	Silver

Body / Panel Condition

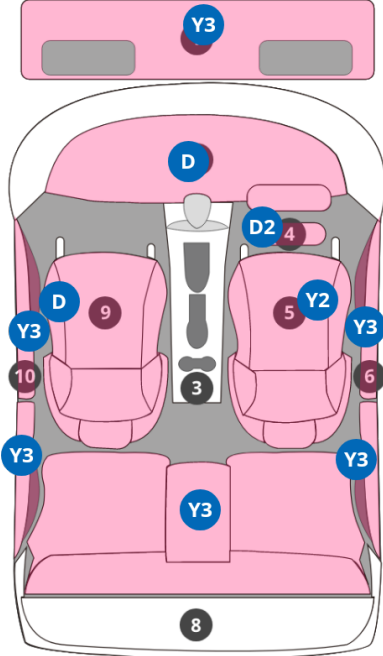
Interior Evaluation : D	Exterior Evaluation : E

<p>a : Cut, Fray d : Loose, Deformed k : Animal Hair s : Smell t : Cigarette Burns x : Defective y : Stain</p>

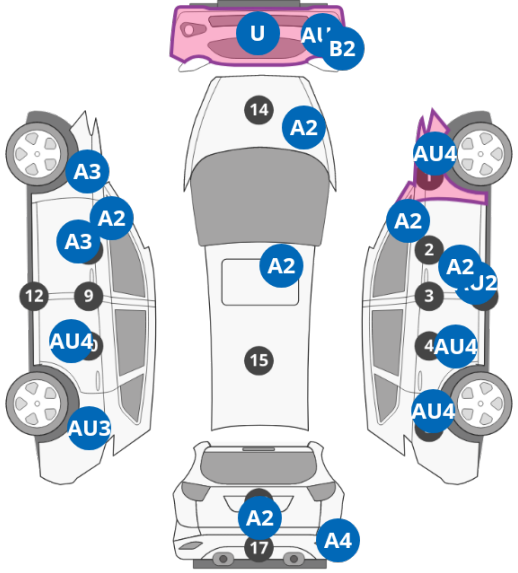
<p>A : Scratch AU : Scratch & Dent B : Modified C : Corrosion G : Stone chip P : Faded S : Rust SC : Rust & Corrosion U : Dent X : Defective Y : Crack, Gap</p>
<p>Remarks (R) Front Seat - Grime - Small / (L) Front Seat - Worn - Yes / (R) Front Trim - Grime - Medium / (L) Front Trim - Grime - Medium / (L) Rear Trim - Grime - Medium / (R) Rear Trim - Grime - Medium / Rear Seat - Grime - Medium / Ceiling - Grime - Medium / Dashboard - Traces of Adhesive Tape - Yes / (L) Front Floor Mat - Worked - Small</p>	<p>Remarks (R) Front Fender, Molding - Repair mark - Yes / (R) Front Fender, Molding - Scratch & Dent - Large / (R) Mirror - Scratch - Small / (R) Center Panel - Scratch & Dent - Small / (R) Front Door, Molding - Scratch - Small / (R) Rear Door, Molding - Scratch & Dent - Large / (R) Rear Fender, Molding - Scratch & Dent - Large / Rear Bumper, Lamps, Panels - Scratch - Large / Trunk Hood, Rear Gate - Scratch - Small / (L) Rear Fender, Molding - Scratch & Dent - Medium / (L) Rear Door, Molding - Scratch & Dent - Large / (L) Front Door, Molding - Scratch - Medium / (L) Mirror - Scratch - Small / (L) Front Fender, Molding - Scratch - Medium / Front Bumper, Grille, Lamps - Repair mark - Yes / Front Bumper, Grille, Lamps - Scratch & Dent - Large / Front Bumper, Grille, Lamps - Modified - Small / Bonnet, Headlight - Scratch - Small / Roof - Scratch - Small / Member (Bolted) - Dent - Yes</p>

<p>Inspector Notes</p>
<p>no warranty booklet and jack, with tools, with spare tire, with LTO plate, scratches on headlight and tail light, cracked tail light, plate light issue</p>
