General Information

Make	Toyota	Model	Land Cruiser
YOM	2024	Odo Meter Reading	10,083
Registration No.	NKC1631	Chassis No.	JTMAA7BJ2P4070991
CC	3.3	Transmission	A/T
Fuel Type	Diesel	Type of Body	SUV
Colour	Black

Body / Panel Condition

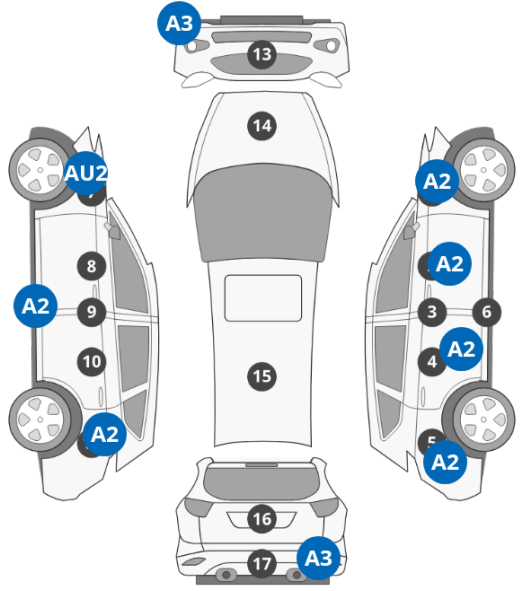
<p>A : Scratch AU : Scratch & Dent B : Modified C : Corrosion G : Stone chip P : Faded S : Rust SC : Rust & Corrosion U : Dent X : Defective Y : Crack, Gap</p>
Remarks Defects not found	Remarks Front Bumper, Grille, Lamps - Scratch - Medium / (L) Front Fender, Molding - Scratch & Dent - Small / (L) Step, In-panel, Side Spoiler - Scratch - Small / (L) Rear Fender, Molding - Scratch - Small / Rear Bumper, Lamps, Panels - Scratch - Medium / (R) Rear Fender, Molding - Scratch - Small / (R) Rear Door, Molding - Scratch - Small / (R) Front Door, Molding - Scratch - Small / (R) Front Fender, Molding - Scratch - Small
Frame Evaluation : A	Functional Evaluation : A
Remarks Defects not found	Remarks Spare Key - Issue - Unexist
