General Information

Make	Toyota	Model	Corolla Altis
YOM	2020	Odo Meter Reading	18,695
Registration No.	NDM3515	Chassis No.	MR2BZ3BE0K2000038
CC	1.8	Transmission	A/T
Fuel Type	Gas	Type of Body	Sedan
Colour	Pearl White

Body / Panel Condition

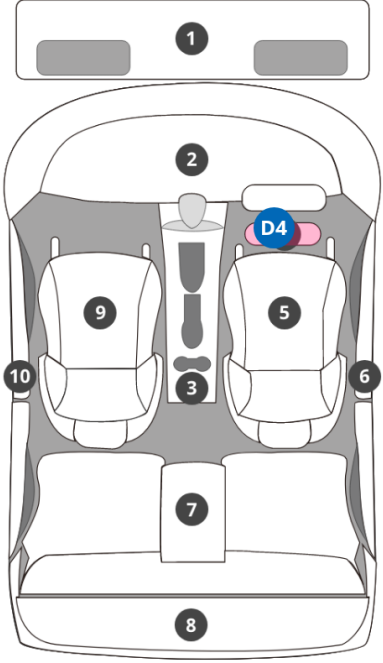
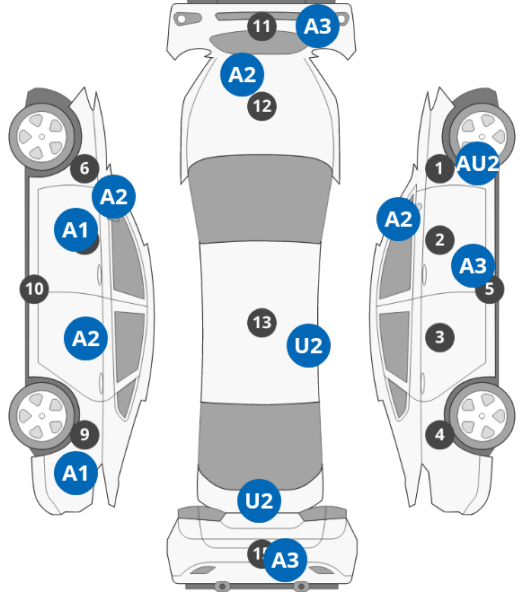
Interior Evaluation :	C	Exterior Evaluation :	C

<p>a : Cut, Fray d : Loose, Deformed k : Animal Hair s : Smell t : Cigarette Burns x : Defective y : Stain</p>		<p>A : Scratch AU : Scratch & Dent B : Modified C : Corrosion G : Stone chip P : Faded S : Rust SC : Rust & Corrosion U : Dent X : Defective Y : Crack, Gap</p>	
<p>Remarks (L) Front Floor Mat - Worked - Large</p>		<p>Remarks (R) Front Fender, Molding - Scratch & Dent - Small / Bonnet, Headlight - Scratch - Small / Trunk Hood, Rear Gate - Dent - Small / (L) Rear Door, Molding - Scratch - Small / Rear Bumper, Lamps, Panels - Scratch - Medium / Roof - Dent - Small / (R) Front Door, Molding - Scratch - Medium / (R) Mirror - Scratch - Small / (L) Mirror - Scratch - Small / (L) Front Door, Molding - Scratch - Minimal / (L) Rear Fender, Molding - Scratch - Minimal / Front Bumper, Grille, Lamps - Scratch - Medium</p>	
Frame Evaluation :	A	Functional Evaluation :	A
