General Information

Make	Toyota	Model	Camry
YOM	2024	Odo Meter Reading	24,085
Registration No.	NOV1597	Chassis No.	MR2B53HK3P4019980
CC	2.5	Transmission	CVT
Fuel Type	Hybrid	Type of Body	Sedan
Colour	Gray

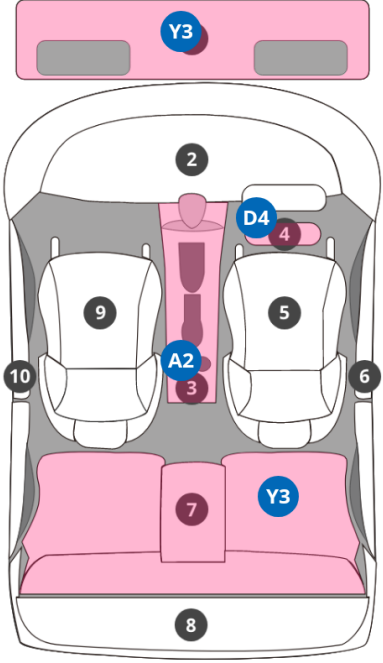
Interior Evaluation : C	Exterior Evaluation : C

<p>a : Cut, Fray d : Loose, Deformed k : Animal Hair s : Smell t : Cigarette Burns x : Defective y : Stain</p>

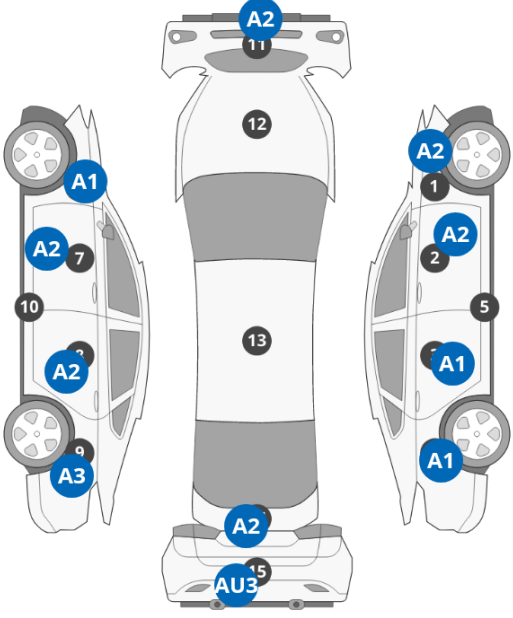
<p>A : Scratch AU : Scratch & Dent B : Modified C : Corrosion G : Stone chip P : Faded S : Rust SC : Rust & Corrosion U : Dent X : Defective Y : Crack, Gap</p>
<p>Remarks Console, Switchs, Vents - Worn, Scratch, Cut, Crack - Small / Ceiling - Grime - Medium / (L) Front Floor Mat - Worked - Large / Rear Seat - Grime - Medium</p>	<p>Remarks Roof - Repair Traces - Yes / (R) Front Fender, Molding - Scratch - Small / (R) Front Door, Molding - Scratch - Small / (R) Rear Door, Molding - Scratch - Minimal / (R) Rear Fender, Molding - Scratch - Minimal / Trunk Hood, Rear Gate - Scratch - Small / (L) Rear Fender, Molding - Scratch - Medium / Rear Bumper, Lamps, Panels - Scratch & Dent - Medium / Front Bumper, Grille, Lamps - Scratch - Small / (L) Rear Door, Molding - Scratch - Small / (L) Front Door, Molding - Scratch - Small / (L) Front Fender, Molding - Scratch - Minimal</p>
