General Information

Make	Toyota	Model	Vios
YOM	2025	Odo Meter Reading	6,767
Registration No.	NJC4448	Chassis No.	PA1B18F3XS4286610
CC	1.3	Transmission	CVT
Fuel Type	Gas	Type of Body	Sedan
Colour	Silver

Body / Panel Condition

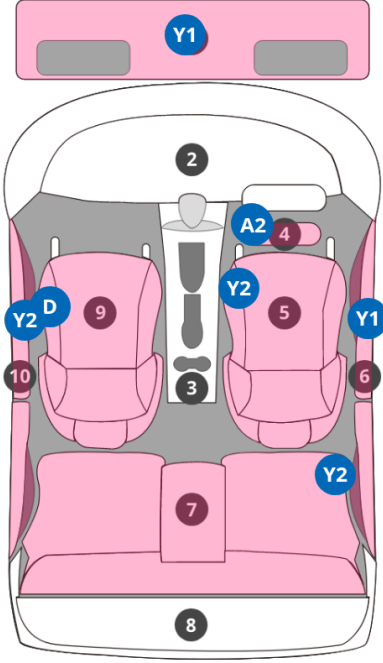
<p>a : Cut, Fray d : Loose, Deformed k : Animal Hair s : Smell t : Cigarette Burns x : Defective y : Stain</p>

<p>A : Scratch AU : Scratch & Dent B : Modified C : Corrosion G : Stone chip P : Faded S : Rust SC : Rust & Corrosion U : Dent X : Defective Y : Crack, Gap</p>
Remarks (L) Front Floor Mat - Worked - Small / (L) Front Floor Mat - Cut, Crack - Small / (L) Front Seat - Worn - Yes / (R) Front Trim - Grime - Minimal / (L) Front Trim - Grime - Small / Ceiling - Grime - Minimal / (R) Front Seat - Grime - Small / Rear Seat - Grime - Small	Remarks (R) Front Fender - Repair Traces - Yes / Bonnet - Repair Traces - Yes / (L) Front Fender - Repair Traces - Yes / (R) Front Fender, Molding - Scratch - Minimal / (R) Mirror - Scratch - Minimal / (R) Front Door, Molding - Scratch - Minimal / (R) Rear Door, Molding - Scratch - Minimal / (R) Rear Fender, Molding - Scratch - Medium / Rear Bumper, Lamps, Panels - Scratch - Medium / Trunk Hood, Rear Gate - Scratch - Small / (L) Rear Fender, Molding - Scratch - Small / (L) Front Door, Molding - Scratch - Small / (L) Rear Door, Molding - Scratch - Small / (L) Mirror - Scratch - Minimal / (L) Front Fender, Molding - Scratch - Minimal / Front Bumper, Grille, Lamps - Scratch - Medium / Bonnet, Headlight - Scratch - Minimal / Roof - Repair mark - Yes / Roof - Scratch - Minimal
