General Information

Make	Toyota	Model	Corolla Altis
YOM	2020	Odo Meter Reading	35,132
Registration No.	NGG9132	Chassis No.	MR2BB3BE7K2001174
CC	1.6	Transmission	CVT
Fuel Type	Gas	Type of Body	Sedan
Colour	Silver

Body / Panel Condition

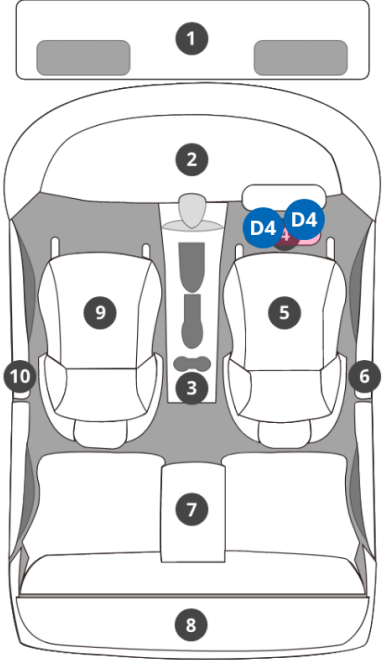
<p>a : Cut, Fray d : Loose, Deformed k : Animal Hair s : Smell t : Cigarette Burns x : Defective y : Stain</p>

<p>A : Scratch AU : Scratch & Dent B : Modified C : Corrosion G : Stone chip P : Faded S : Rust SC : Rust & Corrosion U : Dent X : Defective Y : Crack, Gap</p>
<p>Remarks (L) Front Floor Mat - Worked - Large / (R) Front Floor Mat - Worked - Large</p>	<p>Remarks Front Bumper, Grille, Lamps - Scratch - Large / (L) Mirror - Scratch - Small / Roof - Scratch - Large / (L) Rear Door, Molding - Scratch - Small / (L) Front Door, Molding - Scratch - Small / (L) Rear Fender, Molding - Scratch - Medium / Rear Bumper, Lamps, Panels - Scratch - Small / (R) Rear Door, Molding - Scratch & Dent - Small / (R) Rear Fender, Molding - Scratch - Small / (R) Front Fender, Molding - Scratch & Dent - Small</p>
Frame Evaluation : A	Functional Evaluation : A
