## General Information

<b>Make</b>	Toyota	<b>Model</b>	Innova
<b>YOM</b>	2008	<b>Odo Meter Reading</b>	325,680
<b>Registration No.</b>	ZPA276	<b>Chassis No.</b>	KUN405022409
<b>CC</b>	2.5	<b>Transmission</b>	M/T
<b>Fuel Type</b>	Diesel	<b>Type of Body</b>	Wagon
<b>Colour</b>	White

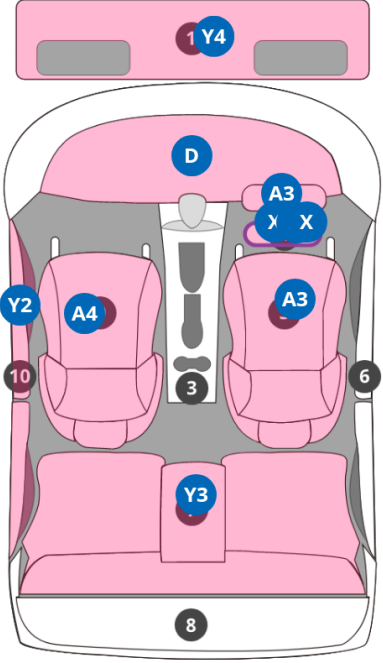
<b>Interior Evaluation :</b> <span style="float: right; color: red; font-weight: bold;">C</span>	<b>Exterior Evaluation :</b> <span style="float: right; color: red; font-weight: bold;">E</span>

<p><b>a</b> : Cut, Fray <b>d</b> : Loose, Deformed <b>k</b> : Animal Hair <b>s</b> : Smell <b>t</b> : Cigarette Burns <b>x</b> : Defective <b>y</b> : Stain</p>

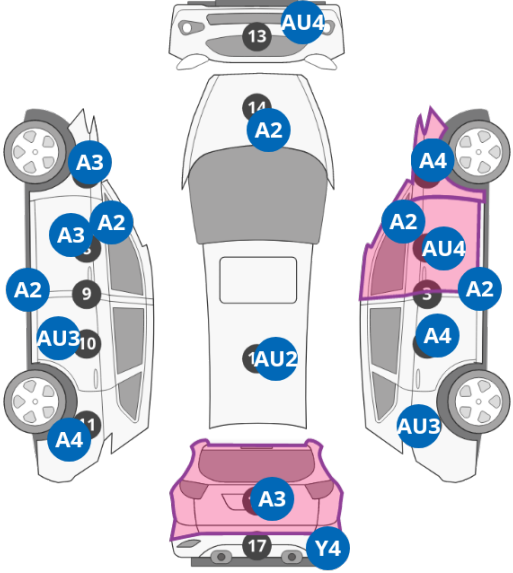
<p><b>A</b> : Scratch <b>AU</b> : Scratch &amp; Dent <b>B</b> : Modified <b>C</b> : Corrosion <b>G</b> : Stone chip <b>P</b> : Faded <b>S</b> : Rust <b>SC</b> : Rust &amp; Corrosion <b>U</b> : Dent <b>X</b> : Defective <b>Y</b> : Crack, Gap</p>
<p><b>Remarks</b> (R) Front Seat - Cut, Crack - Medium / Dashboard - Traces of Adhesive Tape - Yes / (R) Front Floor Mat - Missing - Yes / (L) Front Floor Mat - Missing - Yes / Mat Other - Missing - Yes / Rear Seat - Grime - Medium / (L) Front Seat - Cut, Crack - Large / Ceiling - Grime - Large / Steering Wheel - Worn, Peel, Crack - Medium / (L) Front Trim - Grime - Small</p>	<p><b>Remarks</b> Bonnet - Repair Traces - Yes / (L) Rear Fender - Repair Traces - Yes / Trunk Hood, Rear Gate - Repair Traces - Yes / Roof - Repair Traces - Yes / Trunk Hood, Rear Gate - Repair mark - Yes / (R) Front Door, Molding - Repair mark - Yes / (R) Front Fender, Molding - Repair mark - Yes / Roof - Scratch &amp; Dent - Small / (R) Front Fender, Molding - Scratch - Large / (R) Mirror - Scratch - Small / (R) Front Door, Molding - Scratch &amp; Dent - Large / (R) Rear Door, Molding - Scratch - Large / (R) Rear Fender, Molding - Scratch &amp; Dent - Medium / Rear Bumper, Lamps, Panels - Crack, Gap - Large / Trunk Hood, Rear Gate - Scratch - Medium / (L) Rear Fender, Molding - Scratch - Large / (L) Rear Door, Molding - Scratch &amp; Dent - Medium / (L) Step, In-panel, Side Spoiler - Scratch - Small / (L) Front Door, Molding - Scratch - Medium / (L) Mirror - Scratch - Small / (L) Front Fender, Molding - Scratch - Medium / Bonnet, Headlight - Scratch - Small / Front Bumper, Grille, Lamps - Scratch &amp; Dent - Large / (R) Step, In-panel, Side Spoiler - Scratch - Small</p>
