General Information

Make	Toyota	Model	Vios
YOM	2023	Odo Meter Reading	25,294
Registration No.	NKC8359	Chassis No.	PA1B18F34R4257467
CC	1.3	Transmission	CVT
Fuel Type	Gas	Type of Body	Sedan
Colour	Blue

Body / Panel Condition

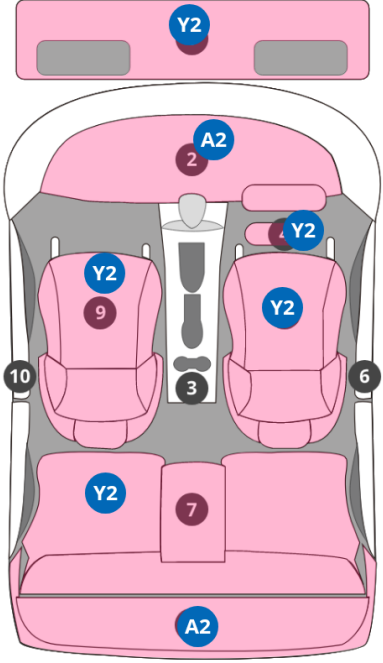
Interior Evaluation : B	Exterior Evaluation : E

<p>a : Cut, Fray d : Loose, Deformed k : Animal Hair s : Smell t : Cigarette Burns x : Defective y : Stain</p>

<p>A : Scratch AU : Scratch & Dent B : Modified C : Corrosion G : Stone chip P : Faded S : Rust SC : Rust & Corrosion U : Dent X : Defective Y : Crack, Gap</p>
<p>Remarks (R) Front Seat - Grime - Small / Rear Seat - Grime - Small / (L) Front Seat - Grime - Small / (L) Front Floor Mat - Grime - Small / Ceiling - Grime - Small / Dashboard - Worn, Scratch, Cut, Crack - Small / Trunk Room - Worn, Scratch, Cut, Crack - Small</p>	<p>Remarks (L) Front Fender - Repair Traces - Yes / Trunk Hood, Rear Gate - Dent - Small / Rear Bumper, Lamps, Panels - Scratch - Medium / (R) Rear Fender, Molding - Scratch & Dent - Medium / (R) Rear Door, Molding - Scratch & Dent - Large / (R) Step, In-panel, Side Spoiler - Scratch & Dent - Large / (R) Front Door, Molding - Scratch & Dent - Medium / (R) Front Fender, Molding - Scratch & Dent - Small / (R) Mirror - Scratch - Minimal / Bonnet, Headlight - Scratch - Small / Front Bumper, Grille, Lamps - Scratch - Large / (L) Front Fender, Molding - Scratch - Small / (L) Front Door, Molding - Scratch - Small / (L) Rear Door, Molding - Scratch - Small / (L) Rear Fender, Molding - Scratch - Small / (L) Step, In-panel, Side Spoiler - Scratch - Minimal / Roof - Scratch - Small</p>
