General Information

Make	Toyota	Model	Vios
YOM	2025	Odo Meter Reading	22,362
Registration No.	NKG2883	Chassis No.	PA1B18F39R4271848
CC	1.3	Transmission	CVT
Fuel Type	Gas	Type of Body	Sedan
Colour	Blackish Red Mica

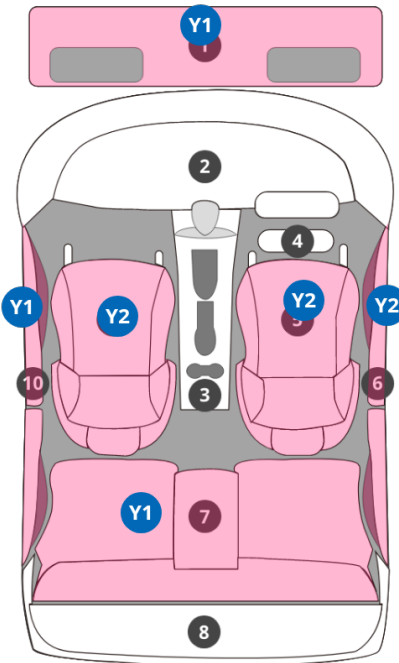
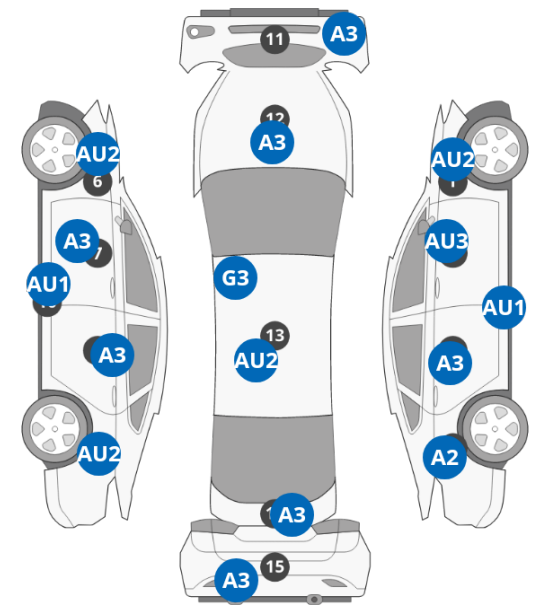
Interior Evaluation :	A	Exterior Evaluation :	E

<p>a : Cut, Fray d : Loose, Deformed k : Animal Hair s : Smell t : Cigarette Burns x : Defective y : Stain</p>		<p>A : Scratch AU : Scratch & Dent B : Modified C : Corrosion G : Stone chip P : Faded S : Rust SC : Rust & Corrosion U : Dent X : Defective Y : Crack, Gap</p>	
<p>Remarks (L) Front Seat - Grime - Small / (R) Front Seat - Grime - Small / (R) Front Trim - Grime - Small / (L) Front Trim - Grime - Minimal / Rear Seat - Grime - Minimal / Ceiling - Grime - Minimal</p>		<p>Remarks (L) Rear Door - Repair Traces - Yes / Roof - Scratch & Dent - Small / (R) Rear Fender, Molding - Scratch - Small / (R) Rear Door, Molding - Scratch - Medium / (R) Front Door, Molding - Scratch & Dent - Medium / (R) Front Fender, Molding - Scratch & Dent - Small / Bonnet, Headlight - Scratch - Medium / (L) Front Fender, Molding - Scratch & Dent - Small / (L) Front Door, Molding - Scratch - Medium / (L) Rear Door, Molding - Scratch - Medium / (L) Step, In-panel, Side Spoiler - Scratch & Dent - Minimal / (R) Step, In-panel, Side Spoiler - Scratch & Dent - Minimal / (L) Rear Fender, Molding - Scratch & Dent - Small / Front Bumper, Grille, Lamps - Scratch - Medium / Trunk Hood, Rear Gate - Scratch - Medium / Rear Bumper, Lamps, Panels - Scratch - Medium / Front Windshield - Scratch, Stone chip - Medium</p>
