General Information

Make	Toyota	Model	Raize
YOM	2023	Odo Meter Reading	23,494
Registration No.	GAQ9764	Chassis No.	MHKAB1BAXPJ046830
CC	1.2	Transmission	CVT
Fuel Type	Gas	Type of Body	SUV
Colour	Gray

Body / Panel Condition

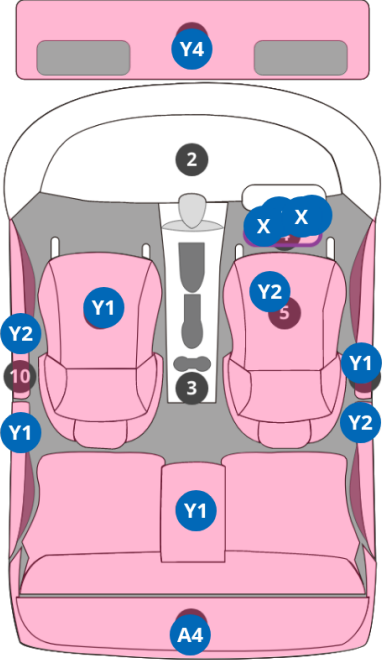
Interior Evaluation : C	Exterior Evaluation : E

<p>a : Cut, Fray d : Loose, Deformed k : Animal Hair s : Smell t : Cigarette Burns x : Defective y : Stain</p>

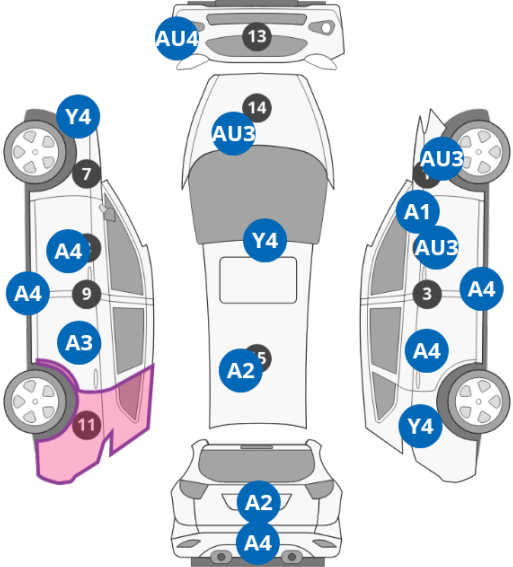
<p>A : Scratch AU : Scratch & Dent B : Modified C : Corrosion G : Stone chip P : Faded S : Rust SC : Rust & Corrosion U : Dent X : Defective Y : Crack, Gap</p>
<p>Remarks (R) Front Seat - Grime - Small / (R) Front Trim - Grime - Minimal / Carpet - Worn, Scratch, Cut, Crack - Small / (R) Rear Trim - Grime - Small / Rear Seat - Grime - Minimal / Trunk Room - Worn, Scratch, Cut, Crack - Large / (L) Rear Trim - Grime - Minimal / (L) Front Trim - Grime - Small / (L) Front Seat - Grime - Minimal / Ceiling - Grime - Large / (L) Front Floor Mat - Missing - Yes / (R) Front Floor Mat - Missing - Yes / Mat Other - Missing - Yes</p>	<p>Remarks (R) Front Fender - Repair Traces - Yes / Bonnet - Repair Traces - Yes / (L) Front Fender - Repair Traces - Yes / (L) Step - Repair Traces - Yes / (L) Rear Fender - Repair Traces - Yes / Front Bumper, Grille, Lamps - Scratch & Dent - Large / (L) Front Fender, Molding - Crack, Gap - Large / Bonnet, Headlight - Scratch & Dent - Medium / (L) Front Door, Molding - Scratch - Large / (L) Rear Door, Molding - Scratch - Medium / (L) Rear Fender, Molding - Repair mark - Yes / (R) Rear Fender, Molding - Crack, Gap - Large / (R) Rear Door, Molding - Scratch - Large / (R) Step, In-panel, Side Spoiler - Scratch - Large / (R) Mirror - Scratch - Minimal / (R) Front Fender, Molding - Scratch & Dent - Medium / Trunk Hood, Rear Gate - Scratch - Small / Rear Bumper, Lamps, Panels - Scratch - Large / Roof - Scratch - Small / (L) Step, In-panel, Side Spoiler - Scratch - Large / Front Windshield - Damaged - Large / (R) Front Door, Molding - Scratch & Dent - Medium</p>
