## General Information

<b>Make</b>	Toyota	<b>Model</b>	Vios
<b>YOM</b>	2021	<b>Odo Meter Reading</b>	30,878
<b>Registration No.</b>	NET2208	<b>Chassis No.</b>	PA1B18F33M4150340
<b>CC</b>	1.3	<b>Transmission</b>	CVT
<b>Fuel Type</b>	Gas	<b>Type of Body</b>	Sedan
<b>Colour</b>	Red Mica Metallic

## Body / Panel Condition

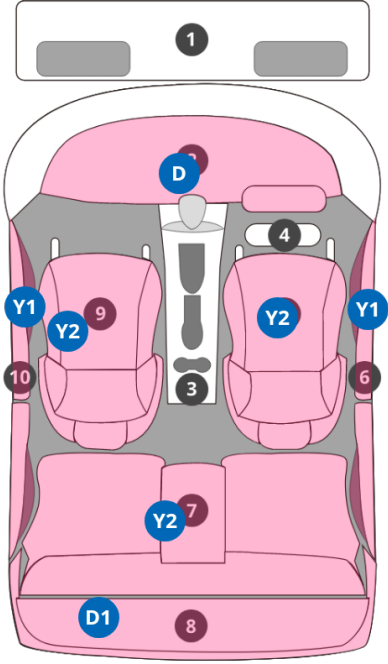
<b>Interior Evaluation :</b> <span style="float: right;"><b>B</b></span>	<b>Exterior Evaluation :</b> <span style="float: right;"><b>E</b></span>

<p><b>a</b> : Cut, Fray <b>d</b> : Loose, Deformed <b>k</b> : Animal Hair <b>s</b> : Smell <b>t</b> : Cigarette Burns <b>x</b> : Defective <b>y</b> : Stain</p>

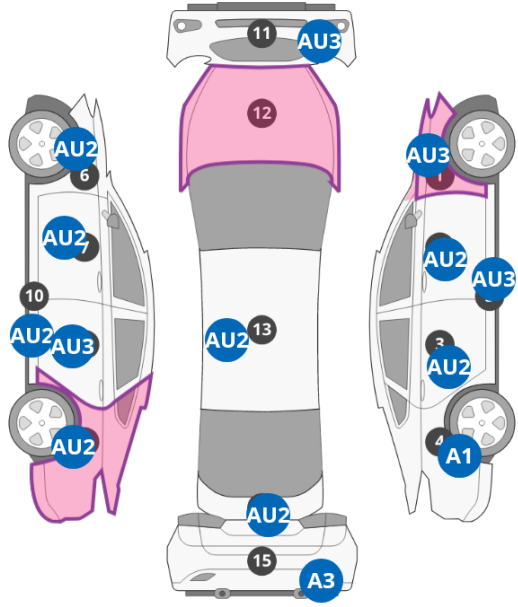
<p><b>A</b> : Scratch <b>AU</b> : Scratch &amp; Dent <b>B</b> : Modified <b>C</b> : Corrosion <b>G</b> : Stone chip <b>P</b> : Faded <b>S</b> : Rust <b>SC</b> : Rust &amp; Corrosion <b>U</b> : Dent <b>X</b> : Defective <b>Y</b> : Crack, Gap</p>
<p><b>Remarks</b> (L) Front Seat - Grime - Small / (R) Front Seat - Grime - Small / Rear Seat - Grime - Small / Dashboard - Traces of Adhesive Tape - Yes / (L) Front Trim - Grime - Minimal / (R) Front Trim - Grime - Minimal / Trunk Room - Worked - Minimal</p>	<p><b>Remarks</b> (R) Front Door - Repair Traces - Yes / (R) Front Fender - Repair Traces - Yes / Bonnet - Repair Traces - Yes / (L) Front Fender - Repair Traces - Yes / (L) Front Door - Repair Traces - Yes / (L) Rear Door - Repair Traces - Yes / (L) Rear Fender - Repair Traces - Yes / Trunk Hood, Rear Gate - Repair Traces - Yes / (R) Rear Fender - Repair Traces - Yes / (R) Rear Door - Repair Traces - Yes / Roof - Repair Traces - Yes / Roof - Scratch &amp; Dent - Small / Trunk Hood, Rear Gate - Scratch &amp; Dent - Small / (L) Rear Fender, Molding - Repair mark - Yes / Bonnet, Headlight - Repair mark - Yes / (R) Front Fender, Molding - Repair mark - Difference in Color / (R) Front Door, Molding - Scratch &amp; Dent - Small / (R) Rear Door, Molding - Scratch &amp; Dent - Small / (L) Front Door, Molding - Scratch &amp; Dent - Small / (L) Rear Fender, Molding - Scratch &amp; Dent - Small / (R) Front Fender, Molding - Scratch &amp; Dent - Medium / Front Bumper, Grille, Lamps - Scratch &amp; Dent - Medium / (L) Front Fender, Molding - Scratch &amp; Dent - Small / (R) Step, In-panel, Side Spoiler - Scratch &amp; Dent - Medium / (R) Rear Fender, Molding - Scratch - Minimal / (L) Step, In-panel, Side Spoiler - Scratch &amp; Dent - Small / Rear Bumper, Lamps, Panels - Scratch - Medium / (L) Rear Door, Molding - Scratch &amp; Dent - Medium</p>
