## General Information

| Make | Toyota | Model | Vios |
| YOM | 2023 | Mileage | 42,053 |

## Overall Evaluation :

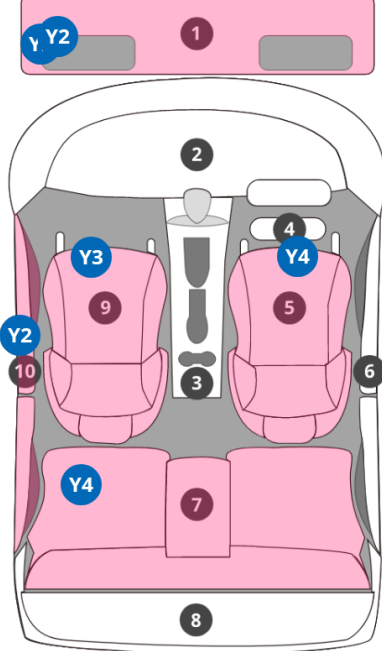
| Interior Evaluation : <span style="color: red;">C</span> | Exterior Evaluation : <span style="color: red;">C</span> |
|---|---|
| <p><b>Remarks</b><br/>(R) Front Seat - Grime - Large / (L) Front Seat - Grime - Medium / (L) Front Trim - Grime - Small / Rear Seat - Grime - Large / Ceiling - Grime - Small / Sunvisor, Sunglass Holder - Grime - Small</p> | <p><b>Remarks</b><br/>Bonnet, Headlight - Dent - Small / (R) Rear Fender, Molding - Scratch &amp; Dent - Minimal / Rear Bumper, Lamps, Panels - Scratch - Large / Trunk Hood, Rear Gate - Scratch &amp; Dent - Medium / (L) Rear Fender, Molding - Dent - Small / Roof Spoiler, Molding - Scratch - Small / Front Bumper, Grille, Lamps - Scratch - Small / (R) Front Door, Molding - Scratch - Minimal / (L) Rear Door, Molding - Scratch - Minimal</p> |
