General Information

Make	Toyota	Model	Avanza
YOM	2025	Odo Meter Reading	7,549
Registration No.	DCA3234	Chassis No.	MHFAA1BY9S0043737
CC	1.3	Transmission	CVT
Fuel Type	Gas	Type of Body	MPV
Colour	Black

Body / Panel Condition

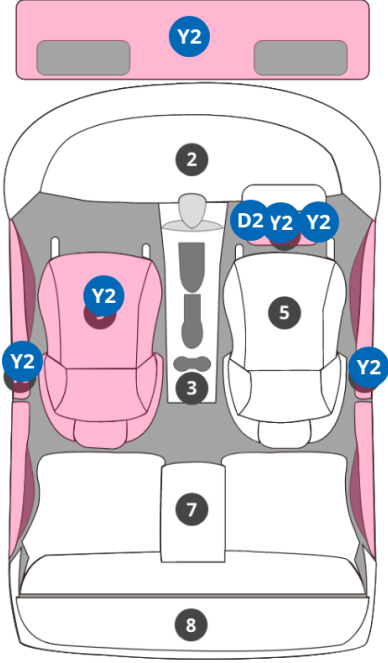
Interior Evaluation : B	Exterior Evaluation : D

<p>a : Cut, Fray d : Loose, Deformed k : Animal Hair s : Smell t : Cigarette Burns x : Defective y : Stain</p>

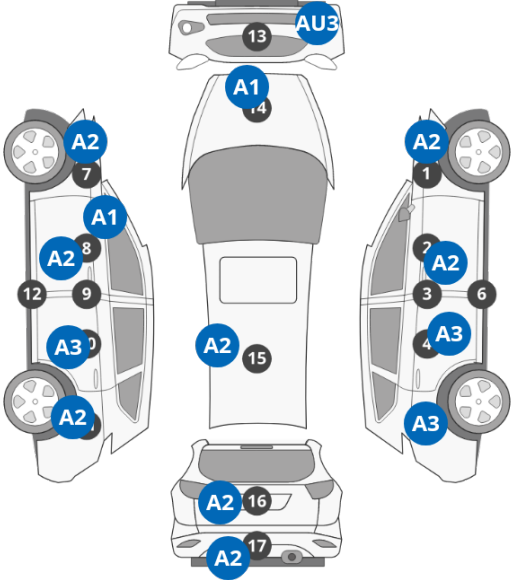
<p>A : Scratch AU : Scratch & Dent B : Modified C : Corrosion G : Stone chip P : Faded S : Rust SC : Rust & Corrosion U : Dent X : Defective Y : Crack, Gap</p>
<p>Remarks (R) Front Floor Mat - Grime - Small / Mat Other - Grime - Small / (L) Front Floor Mat - Worked - Small / (R) Front Trim - Grime - Small / (L) Front Trim - Grime - Small / (L) Front Seat - Grime - Small / Ceiling - Grime - Small</p>	<p>Remarks (R) Front Door, Molding - Scratch - Small / (R) Rear Door, Molding - Scratch - Medium / (R) Rear Fender, Molding - Scratch - Medium / Trunk Hood, Rear Gate - Scratch - Small / Rear Bumper, Lamps, Panels - Scratch - Small / (L) Rear Fender, Molding - Scratch - Small / (L) Rear Door, Molding - Scratch - Medium / (L) Front Door, Molding - Scratch - Small / (L) Mirror - Scratch - Minimal / (L) Front Fender, Molding - Scratch - Small / Bonnet, Headlight - Scratch - Minimal / (R) Front Fender, Molding - Scratch - Small / Front Bumper, Grille, Lamps - Scratch & Dent - Medium / Roof - Scratch - Small</p>
