## General Information

| Make | Toyota | Model | Hilux |
| Registration No. | GBK5333 | Chassis No. | MR0DB8CD0S0196969 |

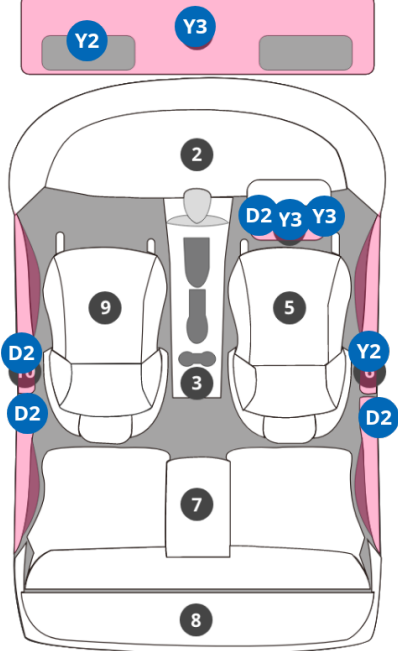
| Interior Evaluation : <b>C</b> | Exterior Evaluation : <b>E</b> |
|---|---|
| <b>Remarks</b><br>(R) Front Floor Mat - Grime - Medium / Sunvisor, Sunglass Holder - Grime - Small / (R) Front Trim - Grime - Small / (R) Rear Trim - Worked - Small / (L) Rear Trim - Worked - Small / Mat Other - Grime - Medium / Ceiling - Grime - Medium / (L) Front Trim - Worked - Small / (L) Front Floor Mat - Worked - Small | <b>Remarks</b><br>(R) Front Door, Molding - Scratch - Small / (R) Rear Door, Molding - Scratch & Dent - Large / (R) Rear Corner Panel - Scratch - Medium / (R) Side Gate - Scratch - Large / Rear Gate - Scratch & Dent - Medium / Rear Bumper, Lamps, Panels - Scratch - Medium / (L) Side Gate - Scratch - Large / (L) Rear Door, Molding - Scratch & Dent - Large / Cab Back Panel - Scratch & Dent - Small / (L) Step, In-panel, Side Spoiler - Scratch & Dent - Small / (L) Mirror - Scratch - Small / (L) Front Fender, Molding - Scratch - Small / Front Bumper, Grille, Lamps - Repair mark - Yes / Front Bumper, Grille, Lamps - Scratch & Dent - Large / Bonnet, Headlight - Dent - Small / Roof - Scratch - Small / (L) Front Door, Molding - Scratch & Dent - Small |

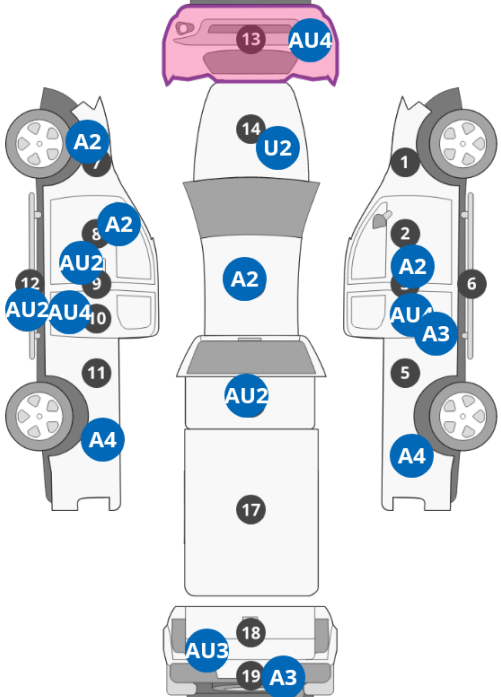
| Inspector Notes |
|---|
| Gap at glove box. Scratches at headlight and taillight. With warranty booklet, tools, jack, spare tire and seat cover. 1 key. No LTO plate. |
