## General Information

<b>Make</b>	Toyota	<b>Model</b>	Vios
<b>YOM</b>	2025	<b>Odo Meter Reading</b>	21,005
<b>Registration No.</b>	GBD8783	<b>Chassis No.</b>	PA1B18F38R4271596
<b>CC</b>	1.3	<b>Transmission</b>	CVT
<b>Fuel Type</b>	Gas	<b>Type of Body</b>	Sedan
<b>Colour</b>	Blue

## Body / Panel Condition

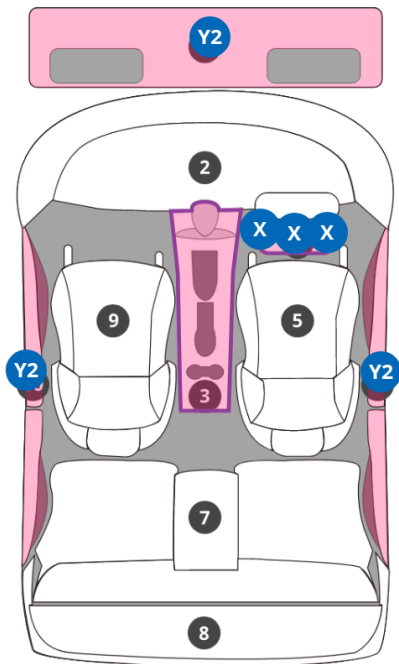
<b>Interior Evaluation :</b> <span style="float: right; color: red; font-weight: bold;">C</span>	<b>Exterior Evaluation :</b> <span style="float: right; color: red; font-weight: bold;">E</span>

<p><b>a</b> : Cut, Fray <b>d</b> : Loose, Deformed <b>k</b> : Animal Hair <b>s</b> : Smell <b>t</b> : Cigarette Burns <b>x</b> : Defective <b>y</b> : Stain</p>

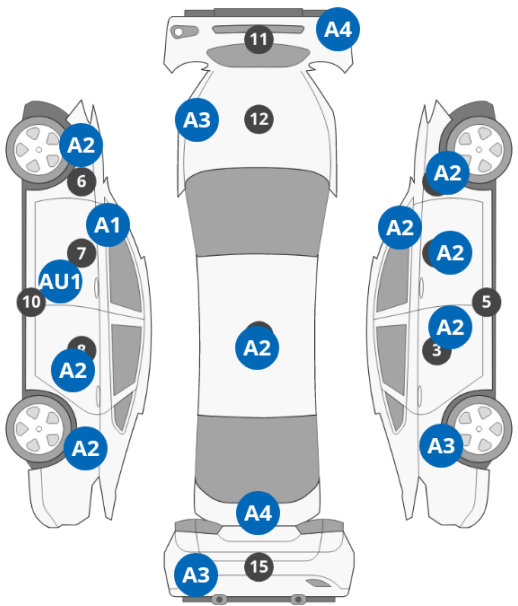
<p><b>A</b> : Scratch <b>AU</b> : Scratch &amp; Dent <b>B</b> : Modified <b>C</b> : Corrosion <b>G</b> : Stone chip <b>P</b> : Faded <b>S</b> : Rust <b>SC</b> : Rust &amp; Corrosion <b>U</b> : Dent <b>X</b> : Defective <b>Y</b> : Crack, Gap</p>
<p><b>Remarks</b> (R) Front Trim - Grime - Small / (R) Front Floor Mat - Missing - Yes / Mat Other - Missing - Yes / (L) Front Trim - Grime - Small / (L) Front Floor Mat - Missing - Yes / Ceiling - Grime - Small / Display, Audio System - Partially Missing - Yes</p>	<p><b>Remarks</b> (L) Mirror - Scratch - Minimal / (L) Front Fender, Molding - Scratch - Small / (L) Rear Door, Molding - Scratch - Small / (L) Rear Fender, Molding - Scratch - Small / (L) Front Door, Molding - Scratch &amp; Dent - Minimal / Trunk Hood, Rear Gate - Scratch - Large / Rear Bumper, Lamps, Panels - Scratch - Medium / (R) Rear Fender, Molding - Scratch - Medium / (R) Rear Door, Molding - Scratch - Small / (R) Mirror - Scratch - Small / (R) Front Door, Molding - Scratch - Small / (R) Front Fender, Molding - Scratch - Small / Bonnet, Headlight - Scratch - Medium / Front Bumper, Grille, Lamps - Scratch - Large / Roof - Scratch - Small</p>
