## General Information

<b>Make</b>	Toyota	<b>Model</b>	Vios
<b>YOM</b>	2023	<b>Odo Meter Reading</b>	85,176
<b>Registration No.</b>	GAK8992	<b>Chassis No.</b>	PA1B18F38P4208883
<b>CC</b>	1.3	<b>Transmission</b>	CVT
<b>Fuel Type</b>	Gas	<b>Type of Body</b>	Sedan
<b>Colour</b>	Black

## Body / Panel Condition

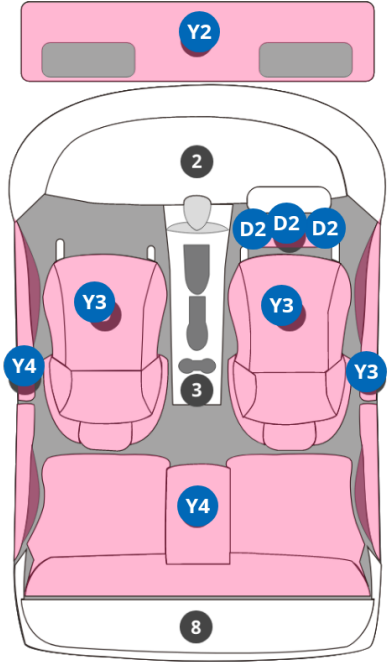
<b>Interior Evaluation :</b> <span style="float: right; color: red; font-weight: bold;">D</span>	<b>Exterior Evaluation :</b> <span style="float: right; color: red; font-weight: bold;">E</span>

<p><b>a</b> : Cut, Fray <b>d</b> : Loose, Deformed <b>k</b> : Animal Hair <b>s</b> : Smell <b>t</b> : Cigarette Burns <b>x</b> : Defective <b>y</b> : Stain</p>

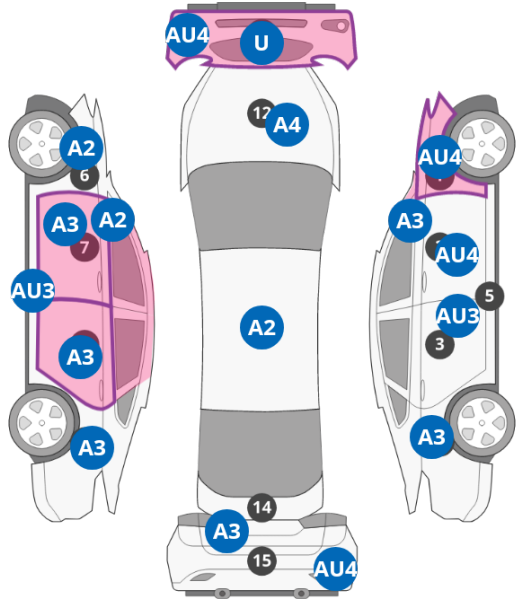
<p><b>A</b> : Scratch <b>AU</b> : Scratch &amp; Dent <b>B</b> : Modified <b>C</b> : Corrosion <b>G</b> : Stone chip <b>P</b> : Faded <b>S</b> : Rust <b>SC</b> : Rust &amp; Corrosion <b>U</b> : Dent <b>X</b> : Defective <b>Y</b> : Crack, Gap</p>
<p><b>Remarks</b>  (R) Front Trim - Grime - Medium / (R) Front Floor Mat - Worked - Small / (R) Front Seat - Grime - Medium / Ceiling - Grime - Small / Rear Seat - Grime - Large / Mat Other - Worked - Small / (L) Front Trim - Grime - Large / (L) Front Seat - Grime - Medium / (L) Front Floor Mat - Worked - Small</p>	<p><b>Remarks</b>  (R) Front Fender, Molding - Repair mark - Yes / (R) Mirror - Scratch - Medium / (R) Front Door, Molding - Scratch &amp; Dent - Large / (R) Rear Door, Molding - Scratch &amp; Dent - Medium / (R) Rear Fender, Molding - Scratch - Medium / Rear Bumper, Lamps, Panels - Scratch &amp; Dent - Large / Trunk Hood, Rear Gate - Scratch - Medium / (L) Rear Fender, Molding - Scratch - Medium / (L) Rear Door, Molding - Repair mark - Yes / (L) Front Door, Molding - Repair mark - Yes / (L) Rear Door, Molding - Scratch - Medium / (L) Step, In-panel, Side Spoiler - Scratch &amp; Dent - Medium / (L) Front Door, Molding - Scratch - Medium / (L) Mirror - Scratch - Small / (L) Front Fender, Molding - Scratch - Small / (R) Front Fender, Molding - Scratch &amp; Dent - Large / Bonnet, Headlight - Scratch - Large / Front Bumper, Grille, Lamps - Repair mark - Yes / Front Bumper, Grille, Lamps - Scratch &amp; Dent - Large / Roof - Scratch - Small / Member (Bolted) - Dent - Yes</p>
