General Information

Body / Panel Condition

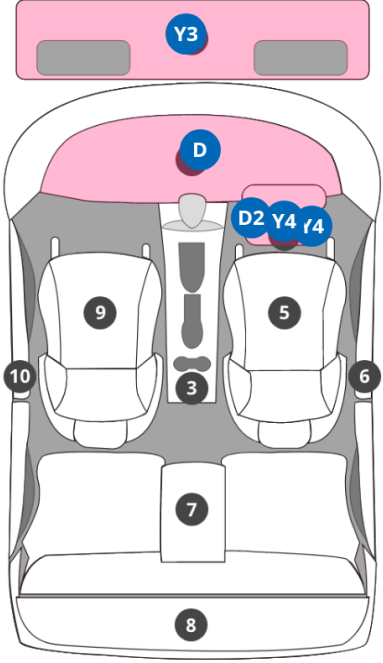
<p>a : Cut, Fray d : Loose, Deformed k : Animal Hair s : Smell t : Cigarette Burns x : Defective y : Stain</p>

<p>A : Scratch AU : Scratch & Dent B : Modified C : Corrosion G : Stone chip P : Faded S : Rust SC : Rust & Corrosion U : Dent X : Defective Y : Crack, Gap</p>
<p>Remarks (R) Front Floor Mat - Grime - Large / Dashboard - Traces of Adhesive Tape - Yes / Ceiling - Grime - Medium / Mat Other - Grime - Large / (L) Front Floor Mat - Worked - Small</p>	<p>Remarks (R) Front Fender, Molding - Scratch & Dent - Minimal / (R) Mirror - Scratch - Minimal / (R) Front Door, Molding - Scratch - Large / (R) Rear Door, Molding - Scratch - Large / (R) Rear Fender, Molding - Scratch - Small / Rear Bumper, Lamps, Panels - Scratch - Small / Trunk Hood, Rear Gate - Scratch - Small / (L) Rear Fender, Molding - Scratch - Small / (L) Rear Door, Molding - Scratch - Small / (L) Mirror - Scratch - Minimal / (L) Front Door, Molding - Scratch & Dent - Small / (L) Front Fender, Molding - Scratch - Small / Bonnet, Headlight - Scratch - Medium / Front Bumper, Grille, Lamps - Scratch & Dent - Large / Roof - Scratch - Large</p>
