## General Information

<b>Make</b>	Toyota	<b>Model</b>	Wigo
<b>YOM</b>	2025	<b>Odo Meter Reading</b>	16,122
<b>Registration No.</b>	GBJ8400	<b>Chassis No.</b>	MHKAA1BC3SJ037951
<b>CC</b>	1.0	<b>Transmission</b>	CVT
<b>Fuel Type</b>	Gas	<b>Type of Body</b>	Hatchback
<b>Colour</b>	Gray

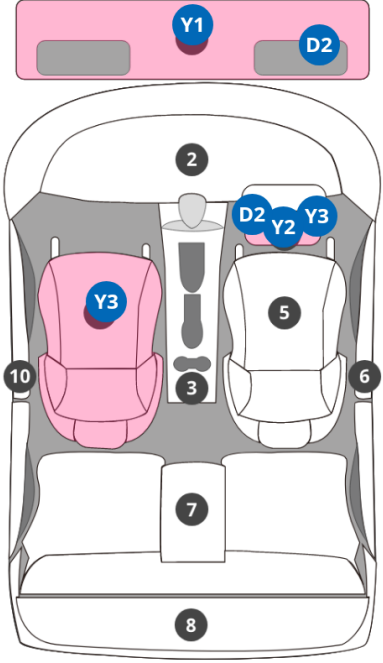
<b>Interior Evaluation :</b> <span style="float: right; color: red; font-weight: bold;">B</span>	<b>Exterior Evaluation :</b> <span style="float: right; color: red; font-weight: bold;">D</span>

<p><b>a</b> : Cut, Fray <b>d</b> : Loose, Deformed <b>k</b> : Animal Hair <b>s</b> : Smell <b>t</b> : Cigarette Burns <b>x</b> : Defective <b>y</b> : Stain</p>

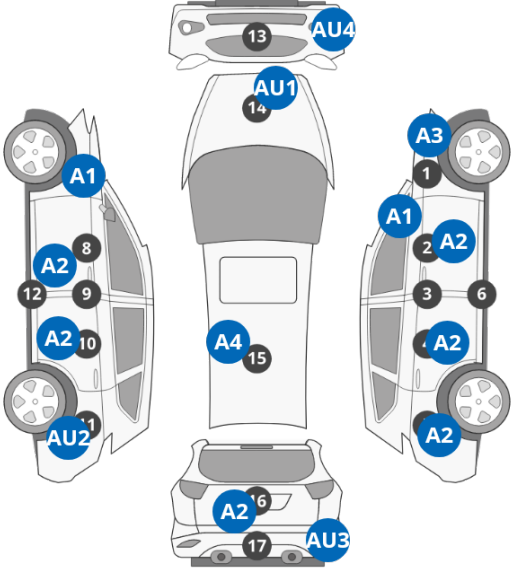
<p><b>A</b> : Scratch <b>AU</b> : Scratch &amp; Dent <b>B</b> : Modified <b>C</b> : Corrosion <b>G</b> : Stone chip <b>P</b> : Faded <b>S</b> : Rust <b>SC</b> : Rust &amp; Corrosion <b>U</b> : Dent <b>X</b> : Defective <b>Y</b> : Crack, Gap</p>
<p><b>Remarks</b> (R) Front Floor Mat - Grime - Medium / Sunvisor, Sunglass Holder - Crinkle - Small / Ceiling - Grime - Minimal / Mat Other - Grime - Small / (L) Front Seat - Grime - Medium / (L) Front Floor Mat - Worked - Small</p>	<p><b>Remarks</b> (L) Front Fender, Molding - Scratch - Minimal / (L) Front Door, Molding - Scratch - Small / (L) Rear Door, Molding - Scratch - Small / (L) Rear Fender, Molding - Scratch &amp; Dent - Small / Trunk Hood, Rear Gate - Scratch - Small / Rear Bumper, Lamps, Panels - Scratch &amp; Dent - Medium / (R) Rear Fender, Molding - Scratch - Small / (R) Rear Door, Molding - Scratch - Small / (R) Mirror - Scratch - Minimal / (R) Front Door, Molding - Scratch - Small / (R) Front Fender, Molding - Scratch - Medium / Bonnet, Headlight - Scratch &amp; Dent - Minimal / Front Bumper, Grille, Lamps - Scratch &amp; Dent - Large / Roof - Scratch - Large</p>
