## General Information

<b>Make</b>	Toyota	<b>Model</b>	Wigo
<b>YOM</b>	2019	<b>Odo Meter Reading</b>	96,926
<b>Registration No.</b>	DAJ2036	<b>Chassis No.</b>	MHKA4DF5FJJ022481
<b>CC</b>	1.0	<b>Transmission</b>	A/T
<b>Fuel Type</b>	Gas	<b>Type of Body</b>	Hatchback
<b>Colour</b>	Gray

## Body / Panel Condition

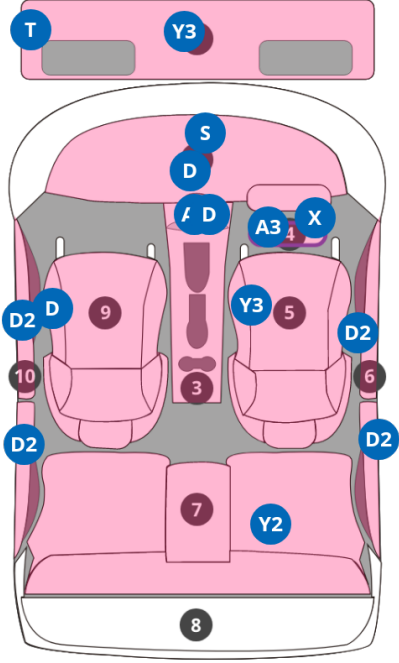
<p><b>a</b> : Cut, Fray <b>d</b> : Loose, Deformed <b>k</b> : Animal Hair <b>s</b> : Smell <b>t</b> : Cigarette Burns <b>x</b> : Defective <b>y</b> : Stain</p>

<p><b>A</b> : Scratch <b>AU</b> : Scratch &amp; Dent <b>B</b> : Modified <b>C</b> : Corrosion <b>G</b> : Stone chip <b>P</b> : Faded <b>S</b> : Rust <b>SC</b> : Rust &amp; Corrosion <b>U</b> : Dent <b>X</b> : Defective <b>Y</b> : Crack, Gap</p>
<p><b>Remarks</b> Overall Interior - Worn as per age - Yes / (L) Front Floor Mat - Cut, Crack - Medium / (L) Front Seat - Worn - Yes / (R) Front Seat - Grime - Medium / Ceiling - Grime - Medium / Rear Seat - Grime - Small / (R) Front Trim - Worked - Small / (R) Rear Trim - Worked - Small / (R) Front Floor Mat - Missing - Yes / Console, Switches, Vents - Worn, Scratch, Cut, Crack - Small / Console, Switches, Vents - Traces of Adhesive Tape - Yes / Dashboard - Traces of Adhesive Tape - Yes / (L) Front Trim - Worked - Small / (L) Rear Trim - Worked - Small / Overall Interior - Smell - Yes / Ceiling - Cigarette Burns - Burnt, Hole</p>	<p><b>Remarks</b> (L) Front Fender - Repair Traces - Yes / Trunk Hood, Rear Gate - Repair Traces - Yes / (R) Rear Fender - Repair Traces - Yes / Roof - Repair Traces - Yes / (R) Mirror - Crack - Cracks / (R) Mirror - Scratch - Small / (R) Front Fender, Molding - Scratch - Small / (R) Step, In-panel, Side Spoiler - Scratch &amp; Dent - Medium / (R) Rear Fender, Molding - Scratch &amp; Dent - Medium / (R) Front Door, Molding - Scratch - Minimal / Rear Bumper, Lamps, Panels - Repair mark - Yes / Front Bumper, Grille, Lamps - Repair mark - Yes / Trunk Hood, Rear Gate - Scratch - Large / Rear Bumper, Lamps, Panels - Crack, Gap - Medium / (L) Rear Door, Molding - Scratch - Large / (L) Front Door, Molding - Scratch &amp; Dent - Large / (L) Rear Fender, Molding - Scratch &amp; Dent - Medium / (L) Mirror - Scratch - Small / (L) Front Fender, Molding - Scratch &amp; Dent - Medium / Front Bumper, Grille, Lamps - Crack, Gap - Large / Bonnet, Headlight - Scratch &amp; Dent - Medium / Roof - Dent - Large / (R) Rear Door, Molding - Scratch &amp; Dent - Medium</p>
