## General Information

| Make | Toyota | Model | Vios |

## Body / Panel Condition

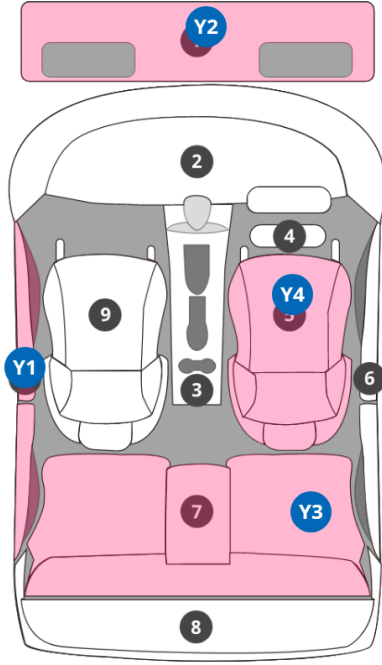
| Interior Evaluation : <span style="color: red;">C</span> | Exterior Evaluation : <span style="color: red;">C</span> |
| <p><b>Remarks</b><br/>Rear Seat - Grime - Medium / (R) Front Seat - Grime - Large / Ceiling - Grime - Small / (L) Front Trim - Grime - Minimal</p> | <p><b>Remarks</b><br/>(R) Front Door, Molding - Scratch - Small / (R) Rear Fender, Molding - Scratch - Medium / Rear Bumper, Lamps, Panels - Dent - Large / (L) Rear Fender, Molding - Scratch &amp; Dent - Medium / (L) Rear Door, Molding - Scratch - Minimal / Front Windshield - Scratch, Stone chip - Small / (L) Front Door, Molding - Scratch &amp; Dent - Minimal / Front Bumper, Grille, Lamps - Scratch &amp; Dent - Small</p> |

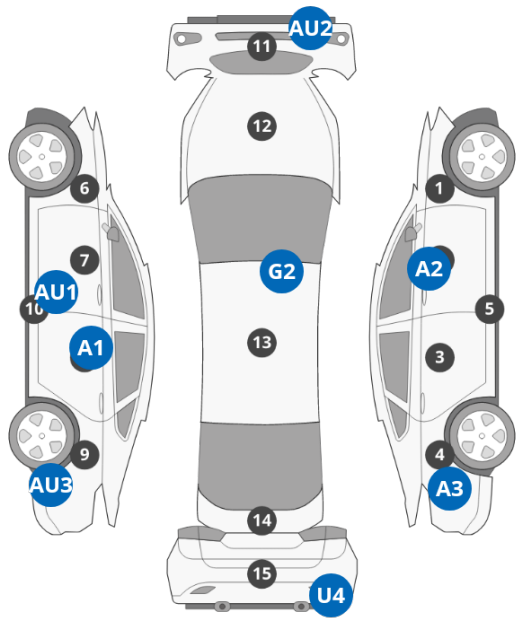
| Inspector Notes |
|---|
| no warranty booklet, with spare tire, with jack and incomplete tools, with LTO plate, scratch/stone chip on front windshield, crack/gap front and rear bumper, front left tire worn |
