## General Information

| Make | Toyota | Model | Vios |
| YOM | 2023 | Mileage | 28,211 |
| Registration No. | NHI7601 | Chassis No. | PA1B18F34P4211019 |

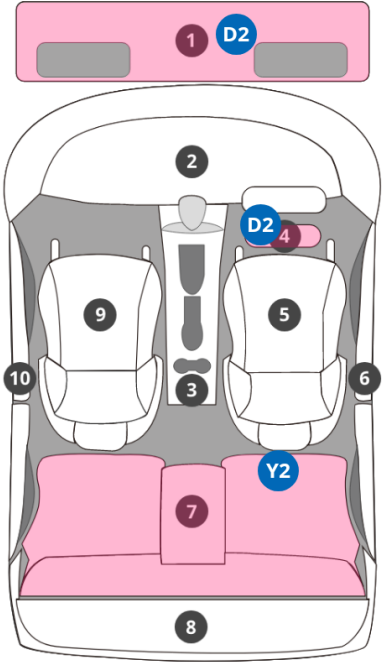
| Interior Evaluation : <span style="color: red; font-weight: bold;">A</span> | Exterior Evaluation : <span style="color: red; font-weight: bold;">B</span> |
| <b>Remarks</b><br>Rear Seat - Grime - Small / (L) Front Floor Mat - Worked - Small / Ceiling - Crinkle - Small | <b>Remarks</b><br>(L) Mirror - Scratch - Small / Front Bumper, Grille, Lamps - Dent - Small / (R) Mirror - Scratch - Minimal / (R) Front Fender, Molding - Scratch - Small / (R) Rear Door, Molding - Dent - Medium |
