## General Information

| Make | Toyota | Model | Vios |
| Registration No. | DBI6040 | Chassis No. | PA1B18F30P4215357 |

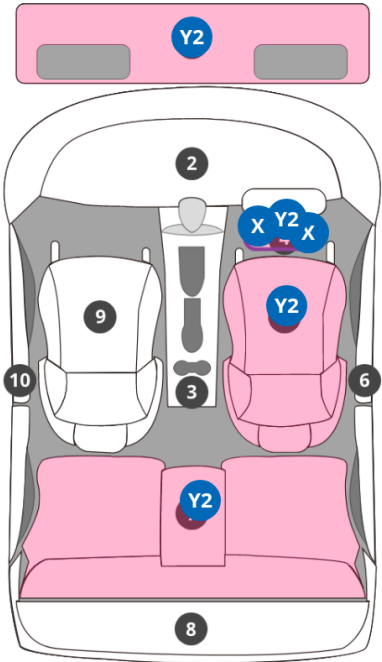
| <b>Remarks</b><br>(L) Front Floor Mat - Missing - Yes / (R) Front Floor Mat - Missing - Yes / Rear Seat - Grime - Small / Mat Other - Grime - Small / (R) Front Seat - Grime - Small / Ceiling - Grime - Small | <b>Remarks</b><br>Rear Bumper, Lamps, Panels - Dent - Small / Trunk Hood, Rear Gate - Scratch & Dent - Minimal / (R) Rear Fender, Molding - Dent - Minimal / Bonnet, Headlight - Scratch & Dent - Minimal / (L) Mirror - Scratch - Minimal / (L) Step, In-panel, Side Spoiler - Scratch - Small / Roof - Scratch - Small / Front Bumper, Grille, Lamps - Scratch - Small |
