## General Information

| Make | Toyota | Model | Wigo |
| YOM | 2023 | Mileage | 4,152 |
| Registration No. | NHC3400 | Chassis No. | MHKA4DF5FNJ073037 |

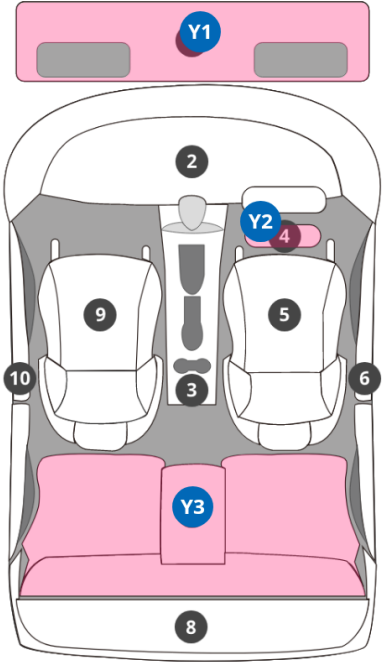
| Interior Evaluation : <b>B</b> | Exterior Evaluation : <b>E</b> |
| <b>Remarks</b><br>Ceiling - Grime - Minimal / Rear Seat - Grime - Medium / (L) Front Floor Mat - Grime - Small | <b>Remarks</b><br>Rear Bumper, Lamps, Panels - Scratch - Medium / (R) Step, In-panel, Side Spoiler - Scratch & Dent - Medium / (R) Rear Fender, Molding - Scratch - Medium / (R) Rear Door, Molding - Scratch - Medium / (R) Mirror - Scratch - Medium / Bonnet, Headlight - Scratch - Small / (L) Mirror - Scratch - Small / (R) Front Door, Molding - Scratch - Medium / Trunk Hood, Rear Gate - Scratch - Small / (L) Rear Door, Molding - Scratch - Small / (L) Front Door, Molding - Scratch - Small / Front Bumper, Grille, Lamps - Scratch & Dent - Medium / Roof - Dent - Small |

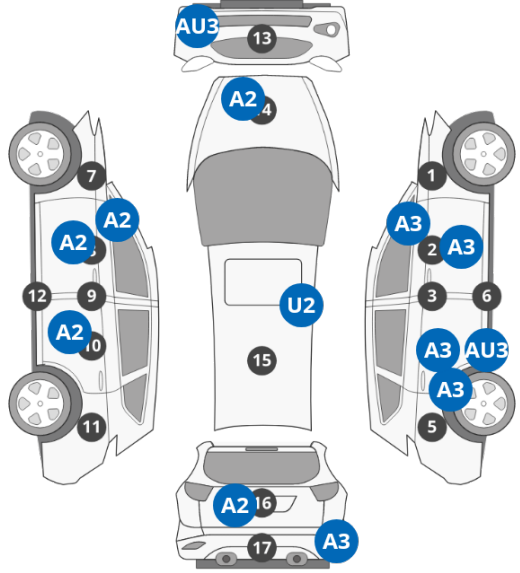
| Inspector Notes |
|---|
| with warranty booklet and spare tire. without jack and tools. without LTO plate. rust marks at the right side exterior. more scratch at right side mirror. |
