## General Information

| Make | Toyota | Model | Vios |
| YOM | 2023 | Mileage | 39,050 |

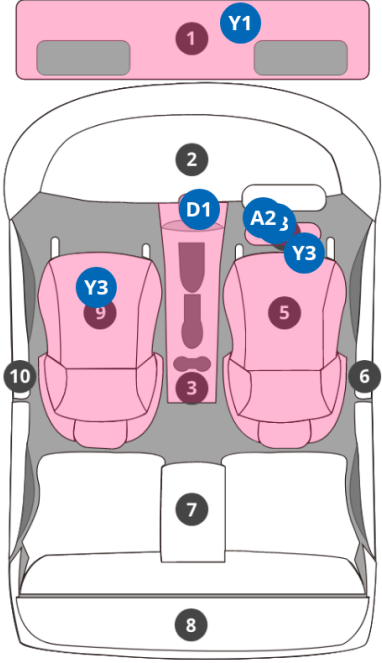
| Interior Evaluation : <b>B</b> | Exterior Evaluation : <b>B</b> |
| <p><b>Remarks</b></p> <p>(R) Front Seat - Grime - Medium / Console, Switches, Vents - Worked - Minimal / (L) Front Floor Mat - Cut, Crack - Medium / Carpet - Worn, Scratch, Cut, Crack - Small / (L) Front Seat - Grime - Medium / Ceiling - Grime - Minimal</p> | <p><b>Remarks</b></p> <p>(R) Front Fender - Repair Traces - Yes / (R) Rear Fender - Repair Traces - Yes / Member (Bolted) - Dent - Yes / Rear Bumper, Lamps, Panels - Scratch - Medium / (L) Rear Door, Molding - Scratch &amp; Dent - Medium / Front Bumper, Grille, Lamps - Scratch - Medium</p> |
