## General Information

| Make | Suzuki | Model | Dzire |

## Body / Panel Condition

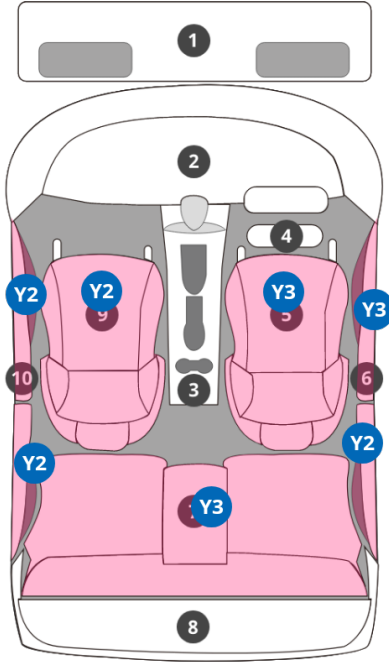
| Interior Evaluation : <span style="color: red; font-weight: bold;">C</span> | | Exterior Evaluation : <span style="color: red; font-weight: bold;">D</span> | |
|---|--|---|--|
| <p><b>Remarks</b></p> <p>(R) Front Seat - Grime - Medium / (R) Front Trim - Grime - Medium / Rear Seat - Grime - Medium / (R) Rear Trim - Grime - Small / (L) Rear Trim - Grime - Small / (L) Front Trim - Grime - Small / (L) Front Seat - Grime - Small</p> | | <p><b>Remarks</b></p> <p>(R) Front Door - Repair Traces - Yes / (L) Rear Door, Molding - Scratch - Medium / (L) Front Fender, Molding - Scratch - Small / Front Bumper, Grille, Lamps - Scratch - Large / Bonnet, Headlight - Scratch - Small / (R) Mirror - Scratch - Minimal / (R) Front Fender, Molding - Scratch - Minimal / (R) Front Door, Molding - Scratch - Minimal / (R) Rear Door, Molding - Scratch - Small / (R) Rear Fender, Molding - Scratch - Small / Trunk Hood, Rear Gate - Scratch &amp; Dent - Small / Rear Bumper, Lamps, Panels - Scratch - Medium / (L) Rear Fender, Molding - Scratch - Small / (L) Front Door, Molding - Scratch - Minimal / Roof - Scratch - Small</p> | |
