## General Information

| Make | Mitsubishi | Model | Mirage |

## Body / Panel Condition

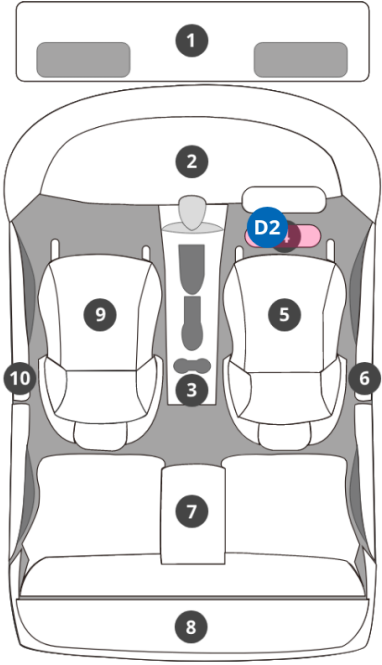
| Interior Evaluation : <span style="color: red; font-weight: bold;">A</span> | Exterior Evaluation : <span style="color: red; font-weight: bold;">D</span> |
|---|---|
| <b>Remarks</b><br>(L) Front Floor Mat - Worked - Small | <b>Remarks</b><br>(R) Front Fender, Molding - Partially Missing - Yes / (R) Front Door, Molding - Scratch & Dent - Medium / (R) Rear Door, Molding - Scratch - Medium / (R) Rear Fender, Molding - Scratch - Medium / Rear Bumper, Lamps, Panels - Scratch - Medium / (L) Rear Fender, Molding - Scratch & Dent - Small / (L) Front Door, Molding - Scratch - Small / (L) Rear Door, Molding - Scratch - Small / (L) Front Fender, Molding - Scratch - Small / Front Bumper, Grille, Lamps - Scratch - Medium |
