## General Information

| Make | Toyota | Model | Hiace |
| Registration No. | GBA8331 | Chassis No. | JTFNAFAP3P8034082 |

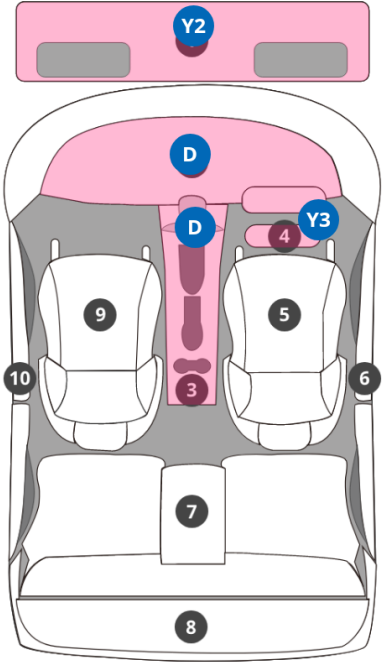
| Interior Evaluation : <b>B</b> | Exterior Evaluation : <b>E</b> |
|---|---|
| <p><b>Remarks</b></p> <p>(R) Front Floor Mat - Grime - Medium / Dashboard - Traces of Adhesive Tape - Yes / Console, Switches, Vents - Traces of Adhesive Tape - Yes / Ceiling - Grime - Small</p> | <p><b>Remarks</b></p> <p>Front Bumper, Grille, Lamps - Scratch &amp; Dent - Large / Bonnet, Headlight - Scratch - Small / (L) Front Fender, Molding - Scratch - Small / (L) Mirror - Scratch - Small / (L) Front Door, Molding - Scratch - Medium / (L) Rear Fender, Molding - Scratch - Large / (L) Step, In-panel, Side Spoiler - Scratch - Small / Trunk Hood, Rear Gate - Scratch - Small / Rear Bumper, Lamps, Panels - Scratch &amp; Dent - Medium / (R) Rear Fender, Molding - Scratch - Small / (R) Rear Door, Molding - Scratch - Small / (R) Center Panel - Scratch - Small / (L) Center Panel - Scratch - Minimal / (R) Front Door, Molding - Scratch - Small / (R) Mirror - Scratch - Minimal / (R) Front Fender, Molding - Scratch - Small</p> |

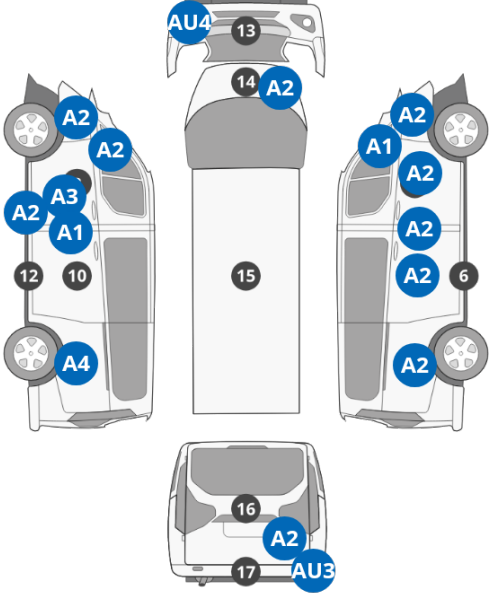
Possible flooding. Scratches at front windshield. Without warranty booklet, tools and jack. With spare tire and seat cover. 1 key. With LTO plate.
