## General Information

| Make | Toyota | Model | Vios |
| Registration No. | GAK2413 | Chassis No. | PA1B18F32P4203355 |

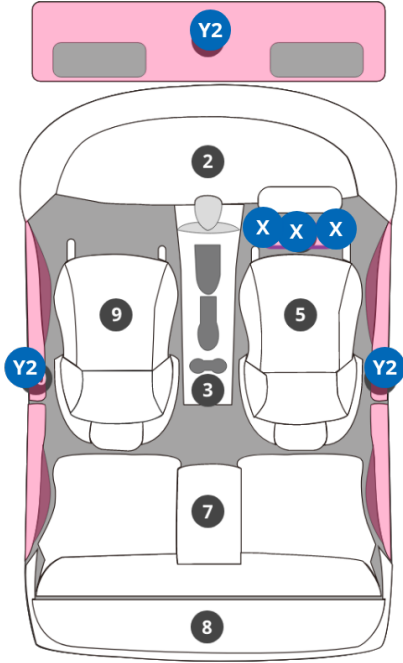
| Interior Evaluation : <span style="color: red;">B</span> | Exterior Evaluation : <span style="color: red;">D</span> |
| <b>Remarks</b><br>Ceiling - Grime - Small / Mat Other - Missing - Yes / (R) Front Floor Mat - Missing - Yes / (L) Front Floor Mat - Missing - Yes / (R) Front Trim - Grime - Small / (L) Front Trim - Grime - Small | <b>Remarks</b><br>Trunk Hood, Rear Gate - Repair Traces - Yes / (L) Front Fender, Molding - Scratch - Small / (L) Mirror - Scratch - Small / (L) Front Door, Molding - Scratch - Small / (L) Rear Fender, Molding - Scratch - Medium / (L) Rear Door, Molding - Scratch - Small / Trunk Hood, Rear Gate - Scratch - Small / Rear Bumper, Lamps, Panels - Scratch & Dent - Medium / (R) Rear Fender, Molding - Scratch - Medium / (R) Rear Door, Molding - Scratch - Small / (R) Front Door, Molding - Scratch - Small / (R) Mirror - Scratch - Minimal / (R) Front Fender, Molding - Scratch - Small / Bonnet, Headlight - Scratch - Small / Front Bumper, Grille, Lamps - Scratch - Small |
