## General Information

| Make | Toyota | Model | Vios |
| YOM | 2017 | Mileage | 109,132 |
| Registration No. | NBU9956 | Chassis No. | PA1B19F30H4023525 |

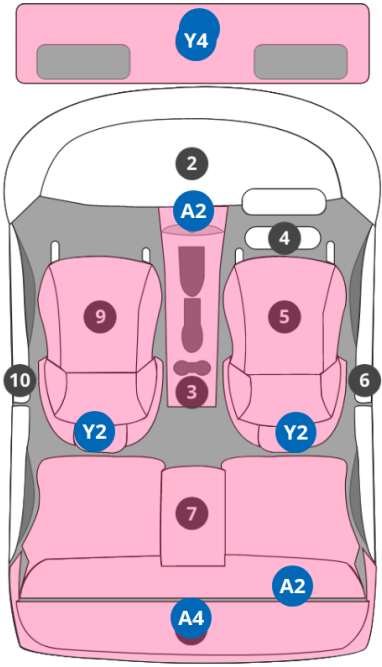
| <b>Remarks</b><br>Overall Interior - Smell - Yes / Ceiling - Grime - Large / Knobs - Worn, Peel, Crack - Small / (L) Front Seat - Grime - Small / (R) Front Seat - Grime - Small / Rear Seat Head Rest - Worn, Peel, Cut - Small / Trunk Room - Worn, Scratch, Cut, Crack - Large | <b>Remarks</b><br>(L) Rear Door - Repair Traces - Yes / (L) Rear Fender, Molding - Dent - Large / Rear Bumper, Lamps, Panels - Scratch - Large / (R) Rear Door, Molding - Scratch & Dent - Large / (R) Front Door, Molding - Scratch & Dent - Large / (R) Step, In-panel, Side Spoiler - Scratch & Dent - Large / (R) Front Fender, Molding - Dent - Large / Bonnet, Headlight - Scratch & Dent - Medium / Front Bumper, Grille, Lamps - Scratch - Large / (L) Front Fender, Molding - Dent - Minimal / (L) Step, In-panel, Side Spoiler - Scratch & Dent - Medium / (L) Front Door, Molding - Dent - Minimal / Trunk Hood, Rear Gate - Dent - Small |

| with LTO plate number/with spare tire/ No warranty booklet/No jack/No tools /Possible flooding/ rusted seat railings |
