## General Information

| Make | Toyota | Model | Wigo |
| YOM | 2024 | Mileage | 13,367 |

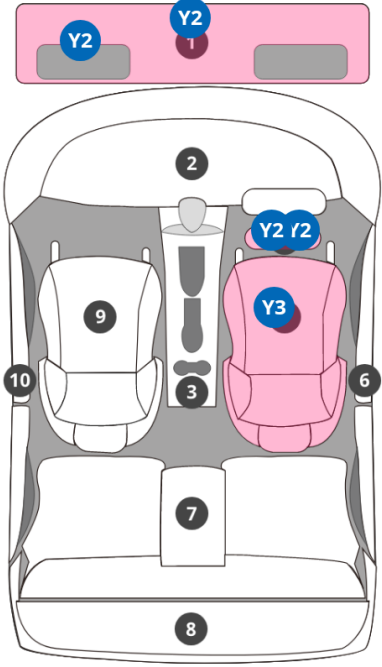
| Interior Evaluation : <b>B</b> | Exterior Evaluation : <b>C</b> |
|---|---|
| <p><b>Remarks</b><br/>(R) Front Floor Mat - Grime - Small / (R) Front Seat - Grime - Medium / Ceiling - Grime - Small / Mat Other - Grime - Small / Sunvisor, Sunglass Holder - Grime - Small</p> | <p><b>Remarks</b><br/>Front Bumper, Grille, Lamps - Scratch &amp; Dent - Large / (R) Rear Door, Molding - Dent - Small / (R) Front Door, Molding - Scratch - Small / Rear Bumper, Lamps, Panels - Scratch - Small / (L) Front Door, Molding - Scratch - Minimal / (L) Rear Door, Molding - Scratch - Small</p> |

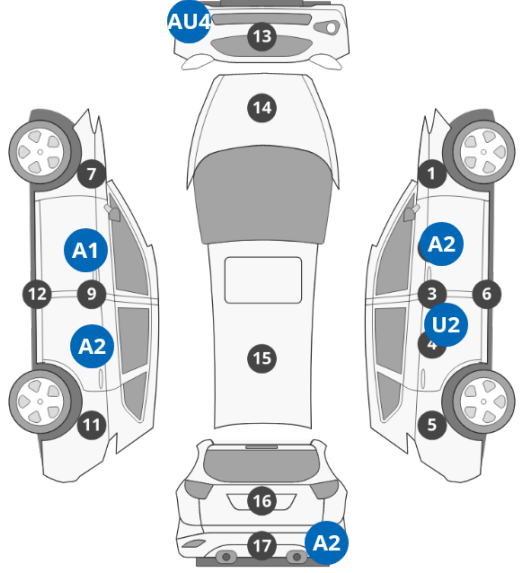
| Inspector Notes |
|---|
| with spare tire, jack and tools. without warranty booklet. without LTO plate. adhesive marks at both side mirrors. Gap at both left and right side front bumper. |
