## General Information

| Make | Dongfeng | Model | Aeolus Mage |

## Body / Panel Condition

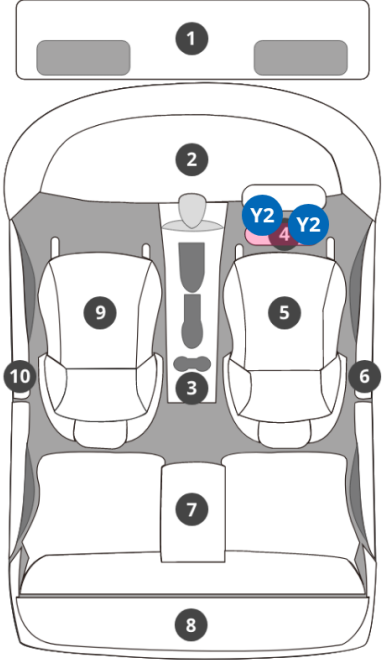
| Interior Evaluation : <span style="color: red;">A</span> | Exterior Evaluation : <span style="color: red;">C</span> |
| <b>Remarks</b><br>(R) Front Floor Mat - Grime - Small / (L) Front Floor Mat - Grime - Small | <b>Remarks</b><br>(L) Front Fender, Molding - Scratch - Minimal / (L) Rear Door, Molding - Scratch - Minimal / Rear Bumper, Lamps, Panels - Scratch - Small / (R) Step, In-panel, Side Spoiler - Scratch - Large / (R) Front Door, Molding - Scratch - Minimal / (R) Front Fender, Molding - Scratch - Minimal / Bonnet, Headlight - Scratch - Minimal / Front Bumper, Grille, Lamps - Scratch & Dent - Large / (L) Front Door, Molding - Scratch - Minimal / (L) Step, In-panel, Side Spoiler - Scratch - Small / Trunk Hood, Rear Gate - Scratch - Minimal / (R) Rear Door, Molding - Scratch - Minimal / (R) Rear Fender, Molding - Scratch - Minimal / (L) Rear Fender, Molding - Scratch - Minimal / Roof - Scratch - Minimal |
