## General Information

| Make | Mitsubishi | Model | Mirage |
| Registration No. | DBS9170 | Chassis No. | PAEA13RJSRA002693 |

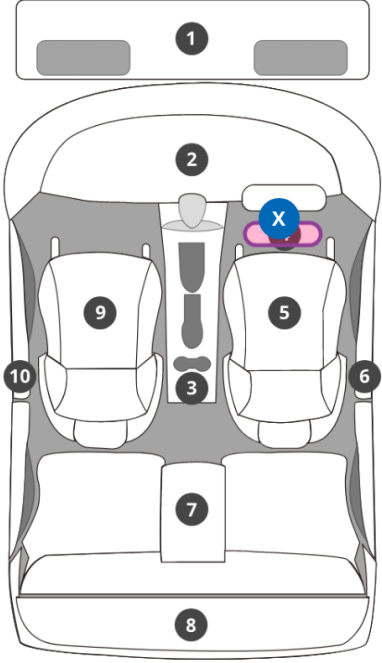
| Interior Evaluation : <b>B</b> | Exterior Evaluation : <b>B</b> |
| <b>Remarks</b><br>(L) Front Floor Mat - Missing - Yes | <b>Remarks</b><br>(R) Mirror - Scratch - Minimal / (R) Front Door, Molding - Dent - Minimal / (R) Rear Door, Molding - Scratch - Minimal / (R) Rear Fender, Molding - Scratch - Minimal / Trunk Hood, Rear Gate - Scratch - Minimal / Rear Bumper, Lamps, Panels - Scratch - Small / (L) Rear Fender, Molding - Scratch - Minimal / (L) Rear Door, Molding - Scratch - Minimal / (L) Front Door, Molding - Scratch - Minimal / Bonnet, Headlight - Scratch - Minimal / Front Bumper, Grille, Lamps - Scratch - Medium |

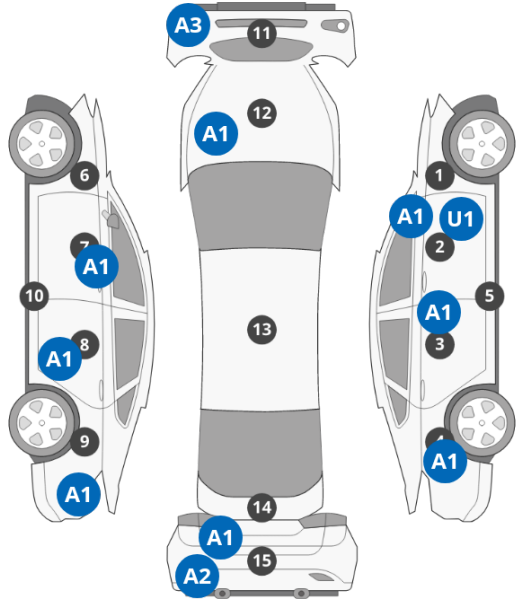
| Inspector Notes |
|---|
| With Lto plate, with warranty booklet, 1key, no spare tire, no jack and tools, scratches on headlights and taillights |
