## General Information

| Make | Mitsubishi | Model | Xpander |
| Registration No. | NIP7702 | Chassis No. | MK2LRNC1WPN02047 |

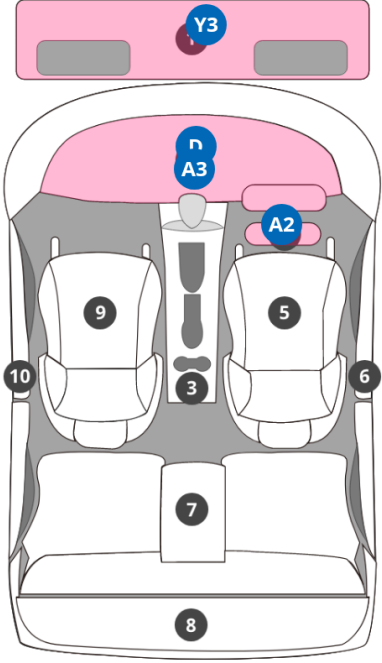
| Interior Evaluation : <b>B</b> | Exterior Evaluation : <b>C</b> |
|---|---|
| <p><b>a</b> : Cut, Fray <b>d</b> : Loose, Deformed <b>k</b> : Animal Hair <b>s</b> : Smell <b>t</b> : Cigarette Burns <b>x</b> : Defective <b>y</b> : Stain</p> | <p><b>A</b> : Scratch <b>AU</b> : Scratch &amp; Dent <b>B</b> : Modified <b>C</b> : Corrosion <b>G</b> : Stone chip <b>P</b> : Faded <b>S</b> : Rust <b>SC</b> : Rust &amp; Corrosion <b>U</b> : Dent <b>X</b> : Defective <b>Y</b> : Crack, Gap</p> |
| <b>Remarks</b><br>Ceiling - Grime - Medium / Dashboard - Traces of Adhesive Tape - Yes / (L) Front Floor Mat - Cut, Crack - Small / Dashboard - Worn, Scratch, Cut, Crack - Medium | <b>Remarks</b><br>(R) Front Door - Repair Traces - Yes / (R) Front Fender - Repair Traces - Yes / (L) Front Fender - Repair Traces - Yes / (L) Rear Fender - Repair Traces - Yes / Trunk Hood, Rear Gate - Repair Traces - Yes / (R) Rear Fender - Repair Traces - Yes / Roof - Repair Traces - Yes / (R) Front Fender, Molding - Scratch - Minimal / (R) Mirror - Scratch - Minimal / (R) Step, In-panel, Side Spoiler - Scratch - Minimal / (R) Front Door, Molding - Scratch - Small / (R) Rear Door, Molding - Scratch - Small / (R) Rear Fender, Molding - Scratch - Minimal / (R) Front Fender, Molding - Repair mark - Yes / Trunk Hood, Rear Gate - Scratch & Dent - Small / Rear Bumper, Lamps, Panels - Scratch & Dent - Small / (L) Rear Fender, Molding - Scratch & Dent - Minimal / (L) Rear Door, Molding - Dent - Medium / (L) Step, In-panel, Side Spoiler - Scratch - Minimal / (L) Front Door, Molding - Scratch - Minimal / (L) Front Fender, Molding - Scratch - Minimal / Bonnet, Headlight - Scratch - Minimal / Front Bumper, Grille, Lamps - Scratch - Minimal / Roof - Scratch & Dent - Minimal / (L) Mirror - Scratch - Minimal |
