## General Information

| Make | Toyota | Model | Rush |

## Body / Panel Condition

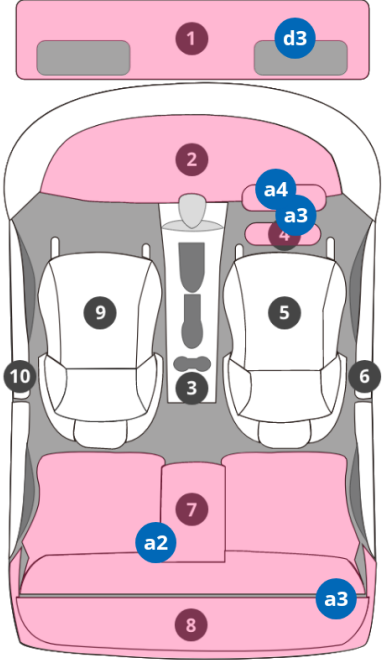
| Interior Evaluation : <b>C</b> | Exterior Evaluation : <b>D</b> |
|---|---|
| <b>Remarks</b><br>(L) Front Floor Lag - Cut, Crack - Medium / Steering Wheel - Worn, Peel, Crack - Large / Sunvisor, Sunglass Holder - Loose, Deformed, Grime - Medium / Seat belt Other - Cut, Crack - Small / Trunk Room - Worn, Scratch, Cut, Crack - Medium | <b>Remarks</b><br>(R) Front Fender - Repair Traces - Yes / (L) Front Fender - Repair Traces - Yes / (L) Front Door - Repair Traces - Yes / Trunk Hood, Rear Gate - Repair Traces - Yes / Front Bumper, Grille, Lamps - Scratch - Large / (R) Step, In-panel, Side Spoiler - Crack, Gap - Medium / Rear Bumper, Lamps, Panels - Dent - Medium / Antennae - Damaged - Yes / (L) Step, In-panel, Side Spoiler - Scratch - Medium / Roof - Dent - Small / (R) Mirror - Scratch, Peeled - Yes / (L) Mirror - Scratch, Peeled - Minimal / (R) Rear Tyre - Crack, Cut - Yes |
