## General Information

| Make | Nissan | Model | Almera |
| YOM | 2025 | Odo Meter Reading | 3,428 |
| Registration No. | BAG9007 | Chassis No. | MNTBAAN18Z0061977 |

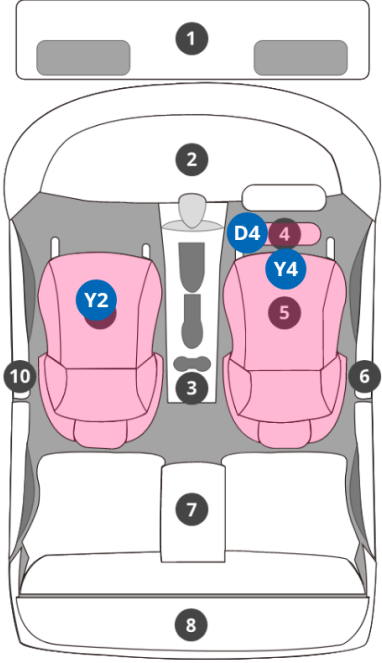
| Interior Evaluation : <span style="color: red;">C</span> | Exterior Evaluation : <span style="color: red;">C</span> |
|---|---|
| <b>Remarks</b><br>(R) Front Seat - Grime - Large / (L) Front Floor Mat - Worked - Large / (L) Front Seat - Grime - Small | <b>Remarks</b><br>(R) Step - Repair Traces - Yes / (R) Rear Fender - Repair Traces - Yes / (R) Rear Door - Repair Traces - Yes / (L) Front Door, Molding - Scratch & Dent - Large / (L) Step, In-panel, Side Spoiler - Scratch & Dent - Medium / Front Bumper, Grille, Lamps - Scratch & Dent - Large / Bonnet, Headlight - Scratch - Minimal / (R) Front Fender, Molding - Scratch - Minimal / (R) Front Door, Molding - Scratch - Small / (R) Rear Door, Molding - Scratch - Small / (R) Rear Fender, Molding - Scratch - Small / Rear Bumper, Lamps, Panels - Scratch - Small / Trunk Hood, Rear Gate - Scratch - Minimal / (L) Rear Fender, Molding - Scratch - Small / (L) Rear Door, Molding - Scratch - Small |
