## General Information

| Make | Mitsubishi | Model | Mirage |
| YOM | 2025 | Odo Meter Reading | 12,221 |
| Registration No. | NKM4926 | Chassis No. | PAEA13MJSRA000211 |

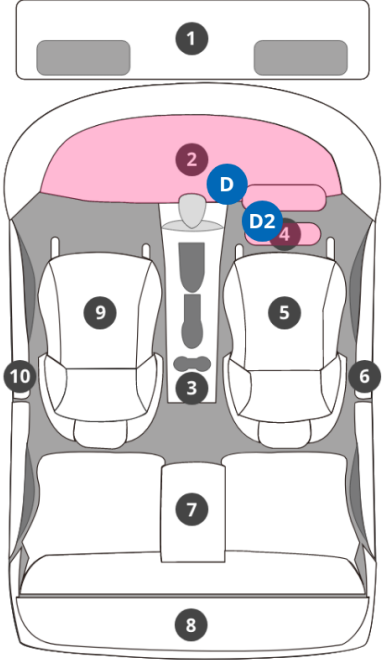
| Interior Evaluation : <b>A</b> | Exterior Evaluation : <b>B</b> |
| <p><b>Remarks</b><br/>Dashboard - Traces of Adhesive Tape - Yes / (L) Front Floor Mat - Worked - Small</p> | <p><b>Remarks</b><br/>Bonnet, Headlight - Dent - Minimal / (R) Front Fender, Molding - Scratch - Minimal / (R) Front Door, Molding - Scratch - Minimal / (R) Rear Door, Molding - Scratch - Minimal / (R) Rear Fender, Molding - Scratch - Minimal / Rear Bumper, Lamps, Panels - Scratch - Small / (L) Rear Fender, Molding - Scratch - Small / (L) Rear Door, Molding - Scratch - Minimal / (L) Front Door, Molding - Scratch - Minimal / (L) Step, In-panel, Side Spoiler - Scratch - Minimal / Front Bumper, Grille, Lamps - Scratch - Small</p> |
