## General Information

| Make | Nissan | Model | Livina |

## Body / Panel Condition

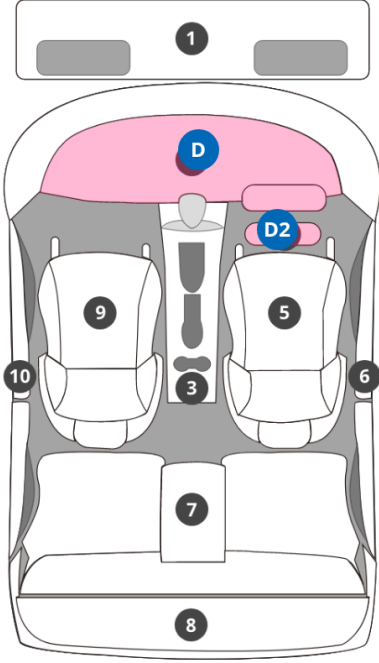
| Interior Evaluation : <span style="color: red; font-weight: bold;">A</span> | Exterior Evaluation : <span style="color: red; font-weight: bold;">D</span> |
| <b>Remarks</b><br>Dashboard - Traces of Adhesive Tape - Yes / (L) Front Floor Mat - Worked - Small | <b>Remarks</b><br>(L) Rear Door, Molding - Scratch - Medium / (L) Front Door, Molding - Scratch & Dent - Medium / Front Bumper, Grille, Lamps - Scratch - Medium / (R) Mirror - Scratch - Medium / Roof - Dent - Minimal / (R) Rear Door, Molding - Scratch - Small / (R) Front Door, Molding - Scratch - Small / Bonnet, Headlight - Scratch - Small / Rear Bumper, Lamps, Panels - Scratch - Small / Trunk Hood, Rear Gate - Scratch - Minimal / (L) Rear Fender, Molding - Scratch - Small / (R) Rear Fender, Molding - Scratch - Small / (R) Front Fender, Molding - Scratch - Minimal / (L) Front Fender, Molding - Scratch - Small |
