## General Information

| Make | Geely | Model | Okavango |
| YOM | 2025 | Odo Meter Reading | 13,048 |
| Registration No. | NOV5539 | Chassis No. | L6T7922Z3SY026321 |

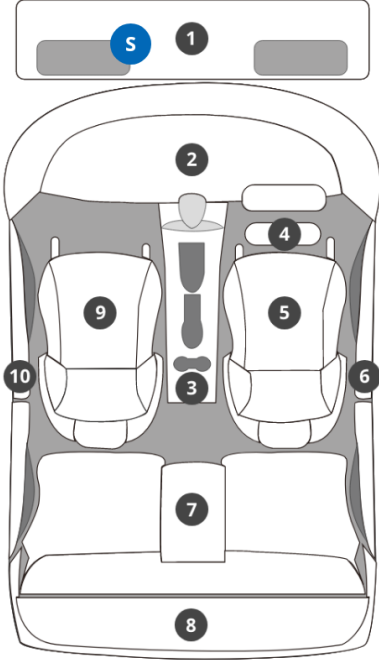
| Interior Evaluation : <b>B</b> | Exterior Evaluation : <b>D</b> |
|---|---|
| <b>Remarks</b><br>Overall Interior - Smell - Yes | <b>Remarks</b><br>Rear Windshield - Damaged - Large / Rear Bumper, Lamps, Panels - Scratch - Large / Front Bumper, Grille, Lamps - Scratch - Medium / (R) Rear Wheel, Cover - Scratch, Corrosion - Small / (R) Rear Fender, Molding - Scratch - Small / (R) Rear Door, Molding - Scratch - Small / (R) Front Door, Molding - Scratch - Small / (R) Front Fender, Molding - Scratch - Small / (L) Front Fender, Molding - Scratch - Small / (L) Front Door, Molding - Scratch - Small / (L) Rear Door, Molding - Scratch - Small / Trunk Hood, Rear Gate - Scratch - Small |
