## General Information

| Make | Chevrolet | Model | Captiva |
| YOM | 2025 | Odo Meter Reading | 5,629 |
| Registration No. | NJA1484 | Chassis No. | LZWADAGAXSB014070 |

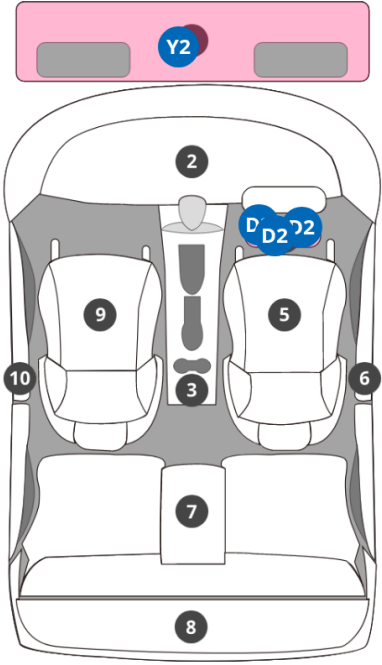
| Interior Evaluation : <span style="color: red; font-weight: bold;">A</span> | Exterior Evaluation : <span style="color: red; font-weight: bold;">C</span> |
| <b>Remarks</b><br>(L) Front Floor Mat - Worked - Small / (R) Front Floor Mat - Worked - Small / Mat Other - Worked - Small / Ceiling - Grime - Small | <b>Remarks</b><br>(R) Front Fender, Molding - Scratch - Minimal / (R) Mirror - Scratch - Minimal / (R) Front Door, Molding - Scratch - Small / (R) Rear Door, Molding - Scratch - Small / (R) Rear Fender, Molding - Scratch - Small / Rear Bumper, Lamps, Panels - Scratch & Dent - Large / Trunk Hood, Rear Gate - Scratch - Small / (L) Rear Fender, Molding - Scratch - Small / (L) Rear Door, Molding - Scratch - Small / (L) Front Door, Molding - Scratch - Small / (L) Mirror - Scratch - Minimal / (L) Front Fender, Molding - Scratch - Minimal / Front Bumper, Grille, Lamps - Scratch - Small / Bonnet, Headlight - Scratch - Minimal / Roof - Scratch - Minimal |

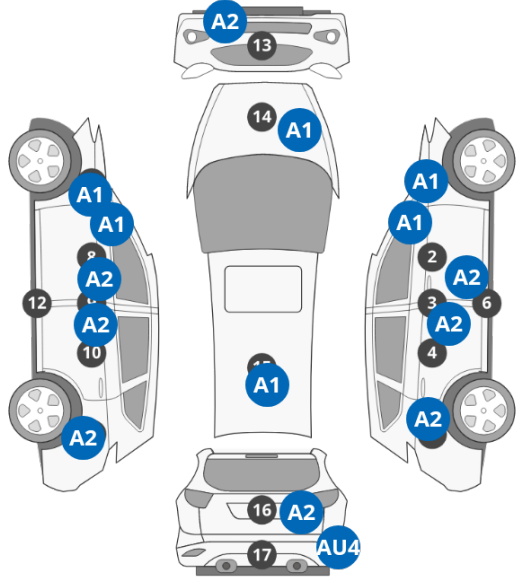
with warranty booklet, jack and incomplete tools, with spare tire, with LTO plate, scratches on tail light
