## General Information

| Make | Mitsubishi | Model | Mirage |
| YOM | 2024 | Odo Meter Reading | 29,407 |
| Registration No. | NKF8153 | Chassis No. | PAEA13RXRRA019532 |

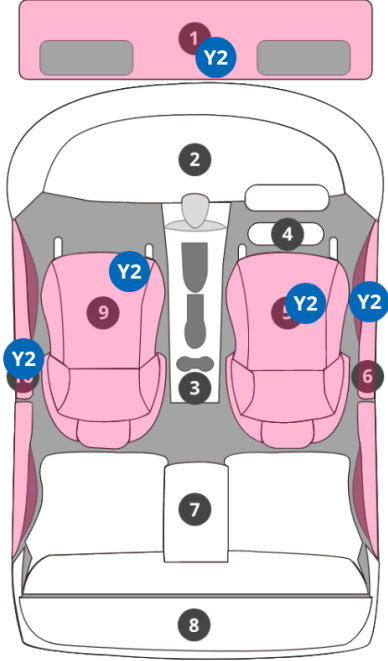
| Interior Evaluation : <b>B</b> | Exterior Evaluation : <b>C</b> |
|---|---|
| <p><b>a</b> : Cut, Fray <b>d</b> : Loose, Deformed <b>k</b> : Animal Hair <b>s</b> : Smell <b>t</b> : Cigarette Burns <b>x</b> : Defective <b>y</b> : Stain</p> | <p><b>A</b> : Scratch <b>AU</b> : Scratch &amp; Dent <b>B</b> : Modified <b>C</b> : Corrosion <b>G</b> : Stone chip <b>P</b> : Faded <b>S</b> : Rust <b>SC</b> : Rust &amp; Corrosion <b>U</b> : Dent <b>X</b> : Defective <b>Y</b> : Crack, Gap</p> |
| <p><b>Remarks</b><br/>(R) Front Seat - Grime - Small / (R) Front Trim - Grime - Small / (L) Front Trim - Grime - Small / (L) Front Seat - Grime - Small / Ceiling - Grime - Small</p> | <p><b>Remarks</b><br/>(R) Front Door - Repair Traces - Yes / (R) Front Fender - Repair Traces - Yes / Roof - Repair Traces - Yes / Front Bumper, Grille, Lamps - Scratch &amp; Dent - Large / (L) Rear Door, Molding - Scratch - Small / (L) Front Door, Molding - Scratch - Minimal / (L) Rear Fender, Molding - Scratch - Small / (R) Rear Fender, Molding - Crack, Gap - Small / (R) Rear Door, Molding - Scratch - Small / (R) Mirror - Scratch - Small / (R) Front Fender, Molding - Crack, Gap - Medium / Bonnet, Headlight - Scratch - Small / Rear Bumper, Lamps, Panels - Scratch - Medium</p> |
